Project No.: 41204

Subject: Leaks in Copper Pipe at Shafston Mansions

Date: 30 October, 2008

Leaks in Copper Pipe at Shafston Mansions

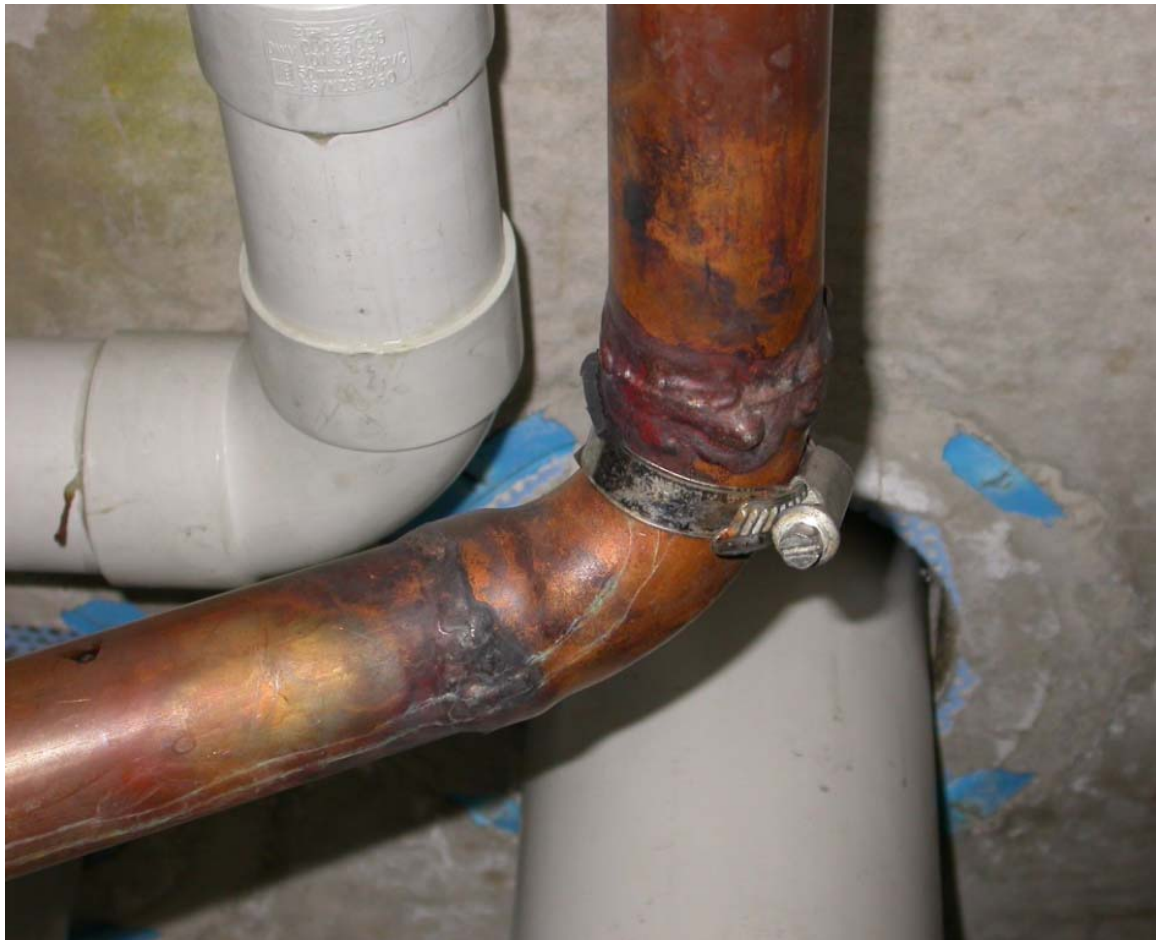
The leak to be repaired was located at the lower end of the 40 mm return riser. The leak had been identified some days previously and a pipe clamp was attached to minimise loss of water prior to repair — see Figure 1. The pinhole leak was adjacent to the soldered joint. One of the plumbers advised that most leaks he had attended were close to bends, tees and joints in the pipe work, but I am not aware of documentary records to confirm this statement. The pipe samples removed for inspection included this bend and a piece approximately 500 mm upstream of the bend.

Figure 1: Location of leak at bottom of 40 mm return line – pipe clamp used to minimise water loss before repair.

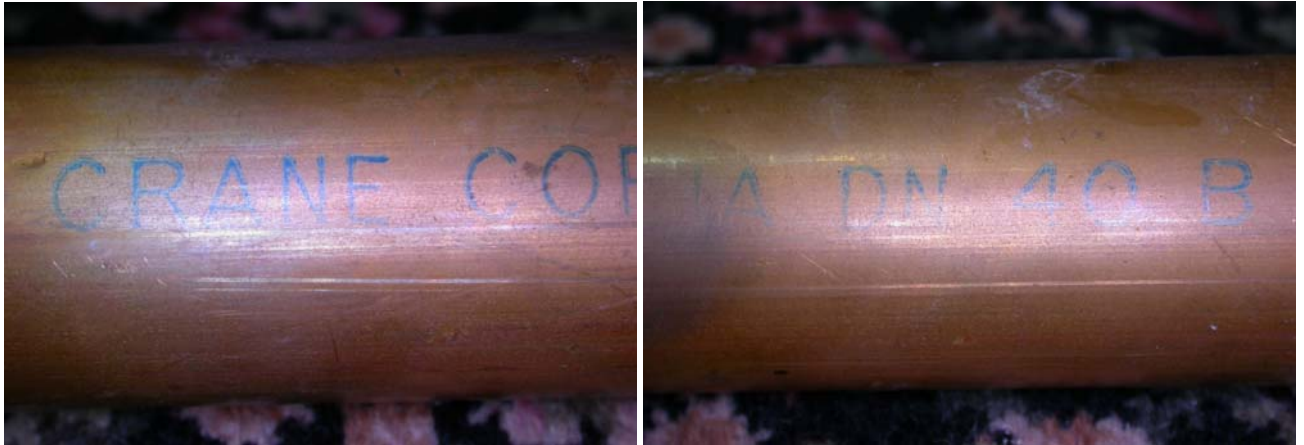
The copper pipe was marked “Crane Copper” and “DN 40B” — see Figure 2.

Figure 2: Manufacturer's identification markings on copper pipe.

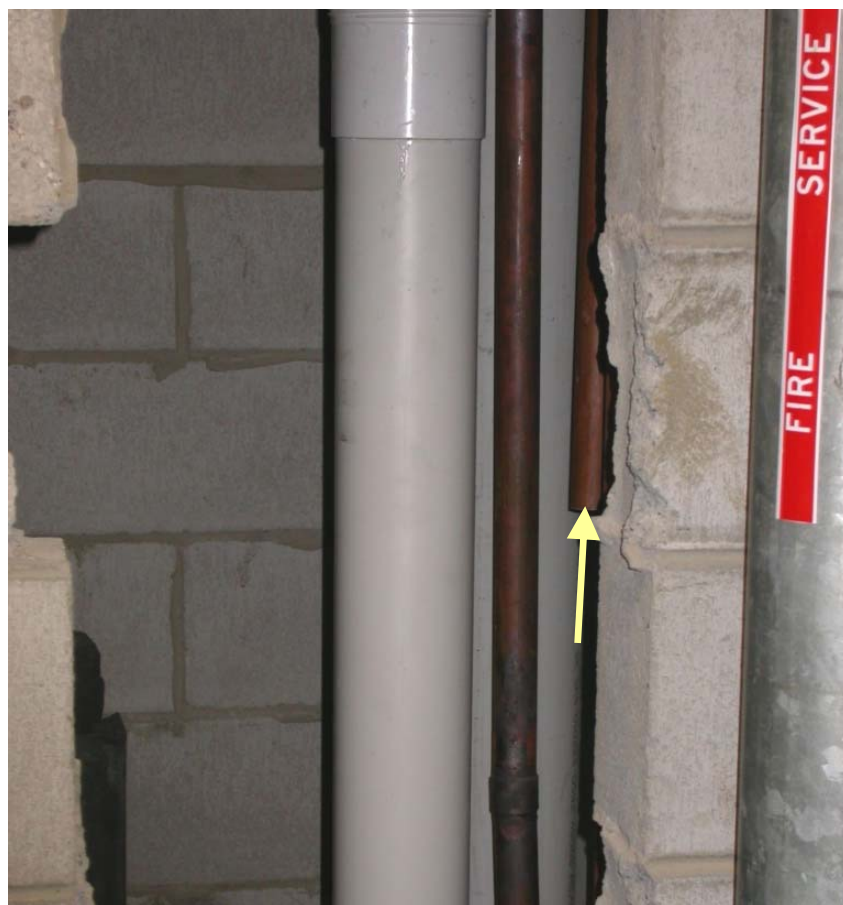
Figure 3 shows a location where the service duct has been entered previously to replace a section of pipe. A piece was removed from the unused section of remaining pipe (arrowed), for comparison with the leaking pipe.

Figure 3: Section of straight pipe on Level 11, remaining from a previous repair/replacement event.

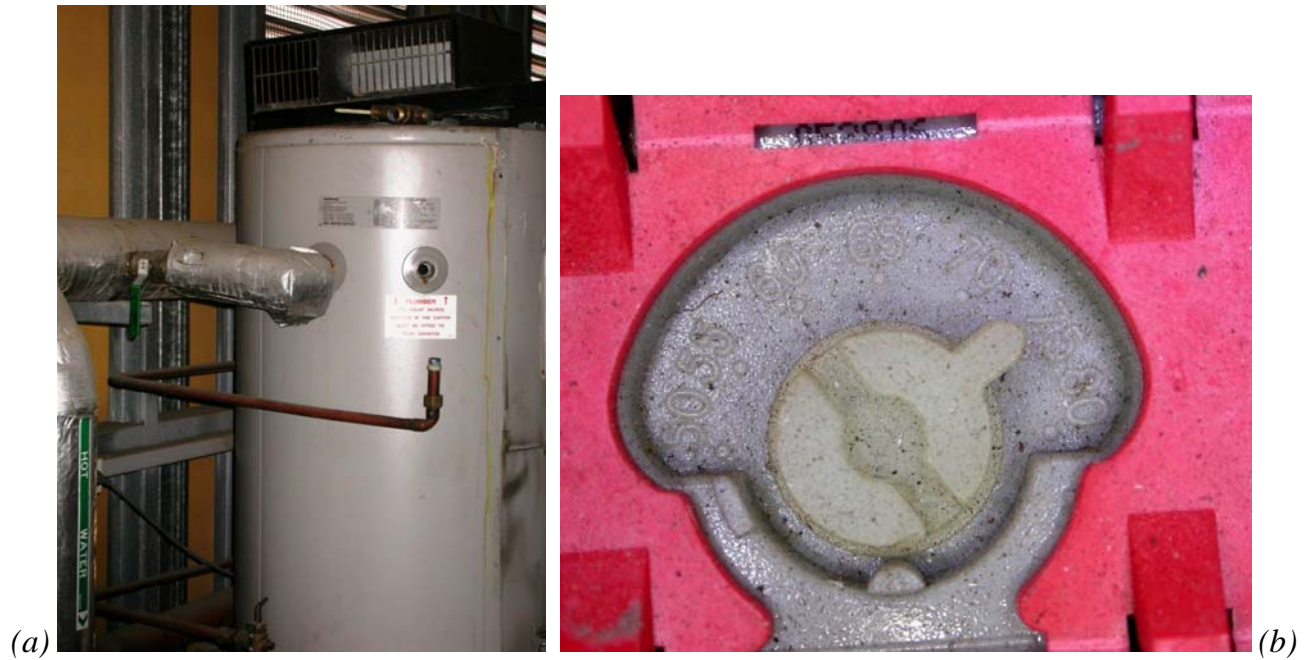
Figure 4: Water heater and temperature controller.

Figure 4(a) shows one of the gas fired water heaters. Of the eight heaters, seven were operational at the time of inspection. Figure 4(b) shows one of the temperature controllers which appears to be set to about 73°C.

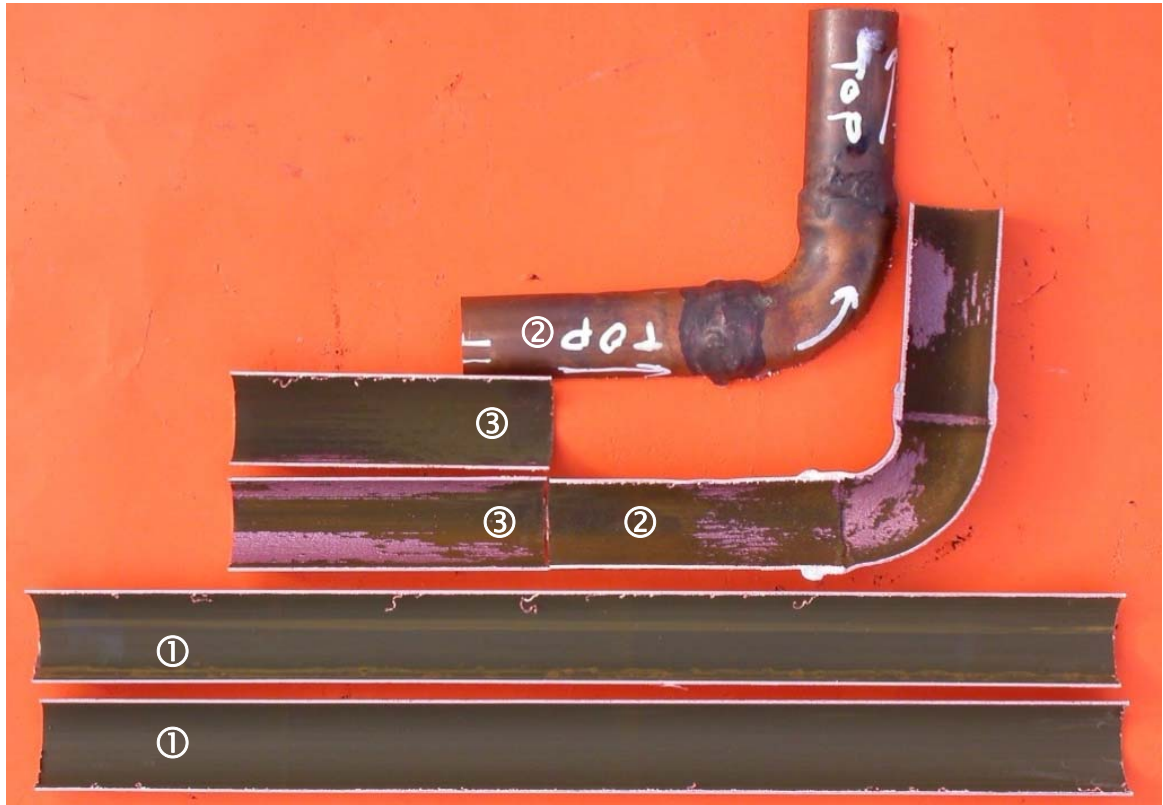
Sectioning of the pipe samples revealed the distribution and characteristics of the attack which led to leakage of the copper pipe. Figure 5 gives an overview of the samples after sectioning. The “furry” appearance at the cut edges is due to burrs from the cutting process.

Figure 5: Pipe samples after sectioning. ① From region shown in Figure 3; no attack evident.
② Leak site as shown in Figure 1; severe attack in several locations (pink coloured patches).
③ From approximately 500 mm upstream of the bend (not adjacent as shown).

Figure 5 and Figure 8 show unambiguous Erosion-Corrosion in a straight section of pipe remote from bends and joints (some 500 mm upstream of the leaking bend). This observation constitutes compelling evidence that there is a systemic problem, as opposed to a problem restricted to regions of local turbulence. Although the attack does not occur in all parts of the system, it is evident that the conditions are so close to critical that any number of local factors can trigger the Erosion-Corrosion. This is suggestive of excessively high general flow velocity (and/or temperature – see section 4.4 below).

The unambiguous observation of the physical manifestation of Erosion-Corrosion, in a section of pipe remote from bends and joints (as shown in Figure 5 and Figure 8), is direct evidence that the general conditions of water velocity and/or temperature are or have been too high. The above quantitative considerations (if we assume the alleged specified and measured velocities are correct) appear to provide an explanation as to why Erosion-Corrosion is likely to occur, or at least is a significant risk, in this system.

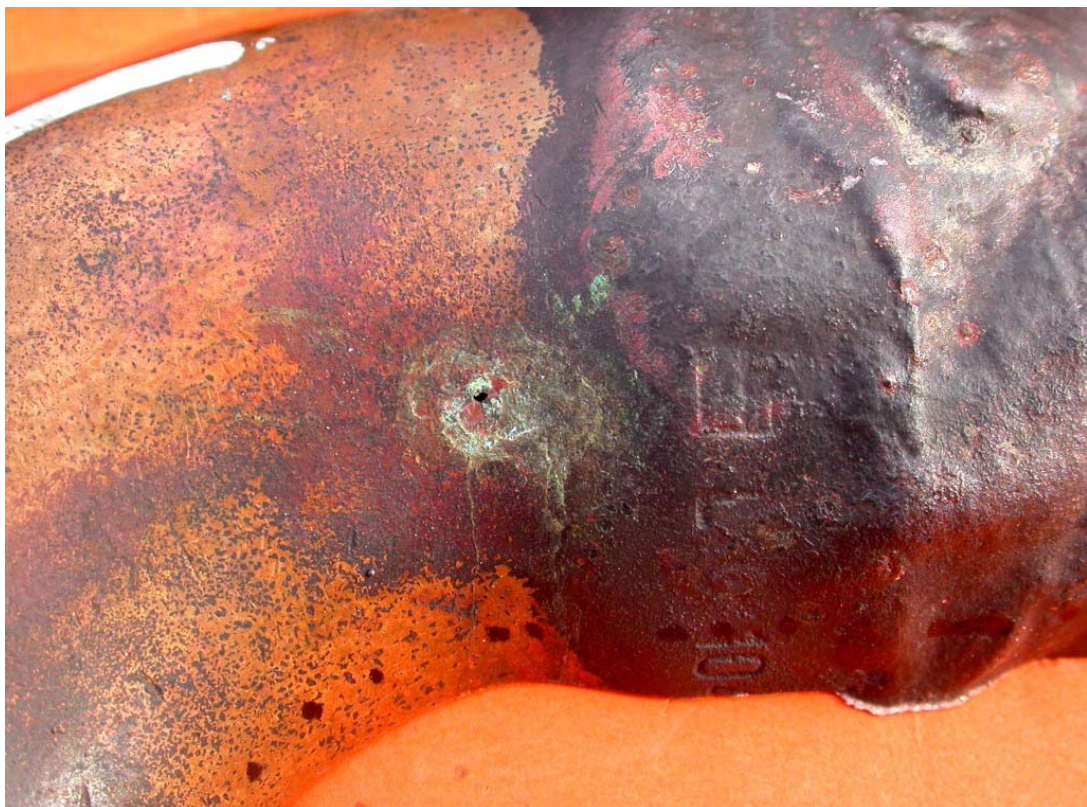
Figure 6 shows the pinhole leak, (a) from the outside of the pipe and (b),(c) from the inside of the pipe. It is clear that the leak has occurred as a result of some form of localised

corrosion. The attack involves localised loss of the protective oxide scale on the inside surface of the pipe, while the surrounding pipe surface maintains its oxide scale.

Figure 6(a): Pinhole leak at bend, viewed from outside of pipe.

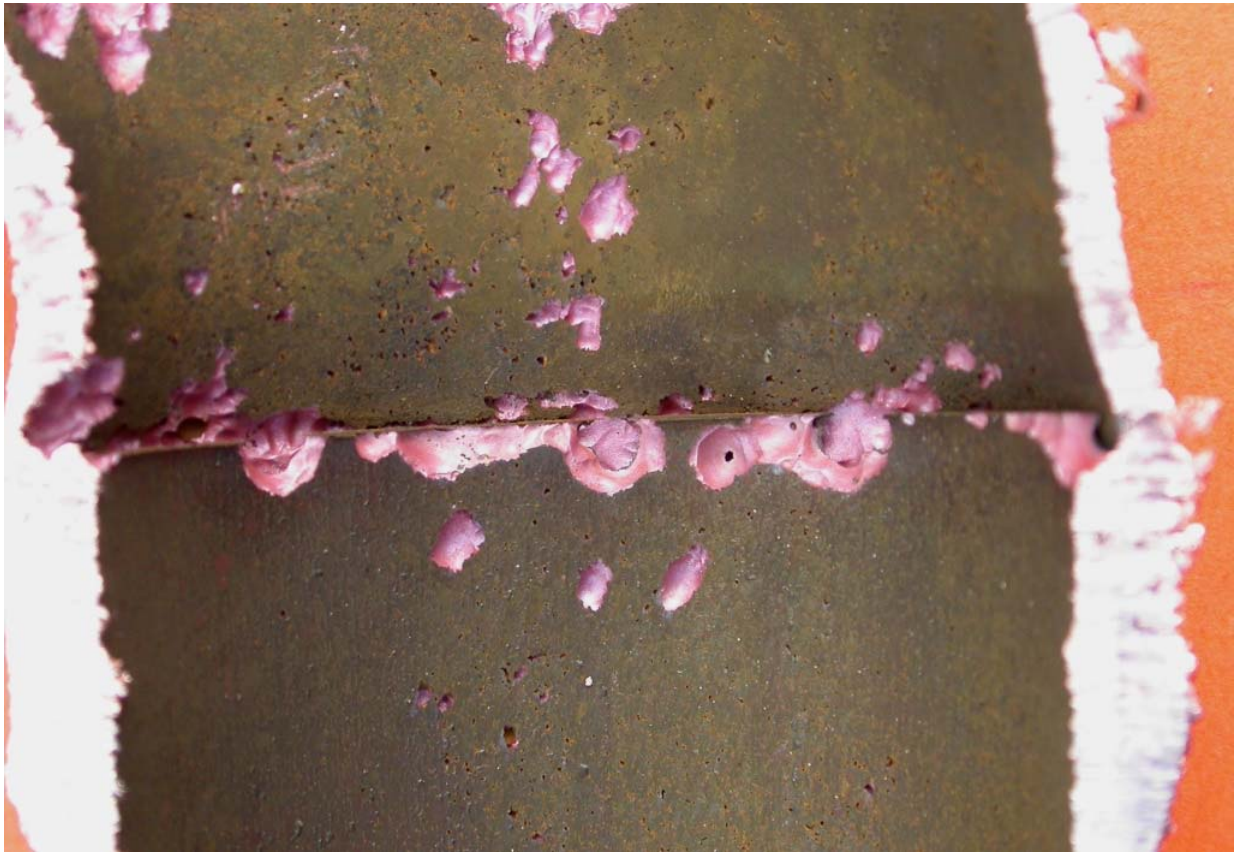
Figure 6(b): Pinhole leak at bend, viewed from inside of pipe.

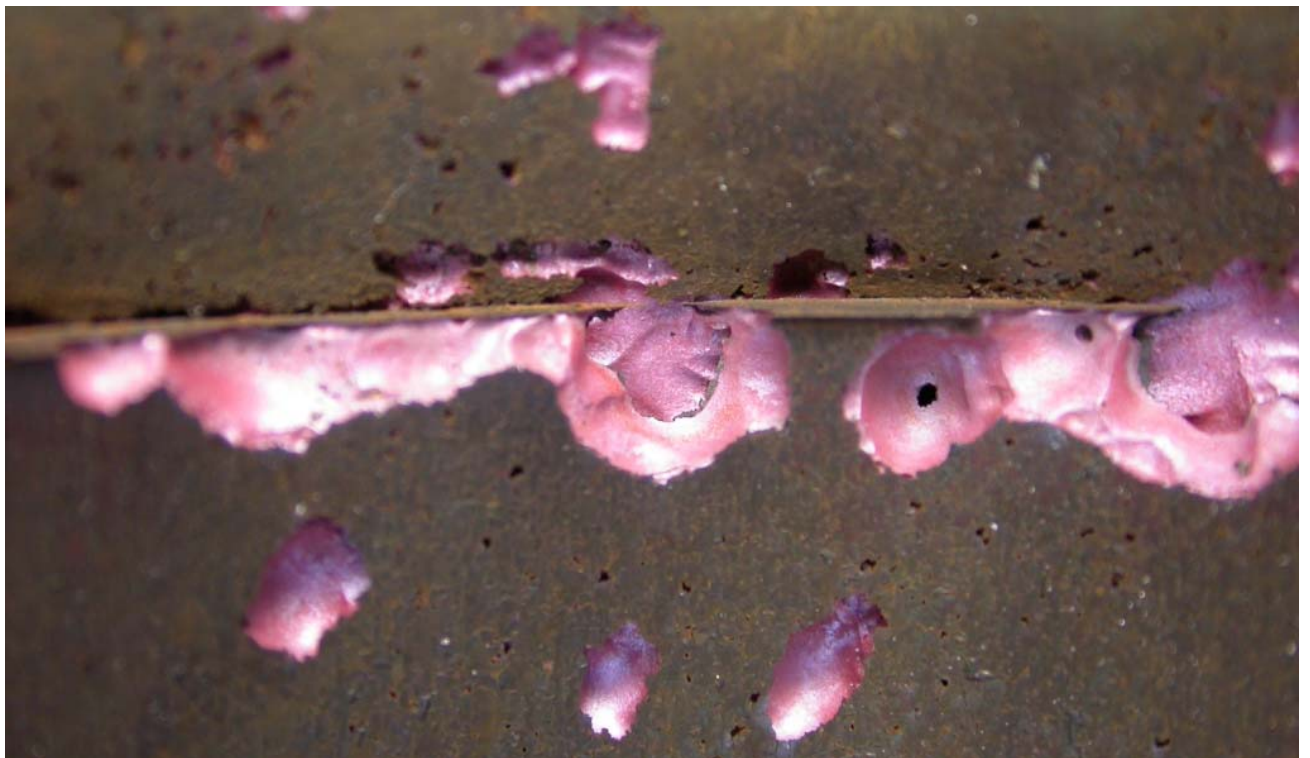
Figure 6(c): Detail of pinhole leak at bend, viewed from inside of pipe.

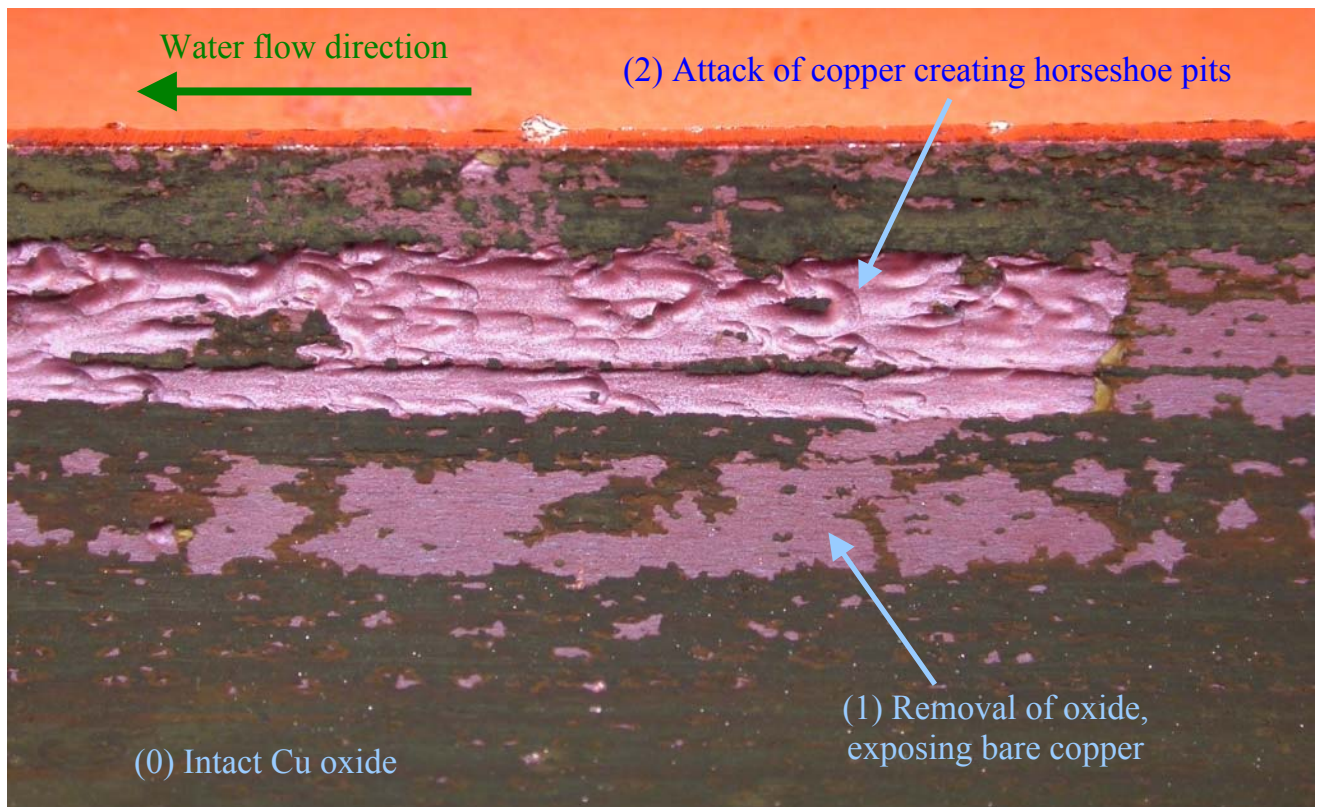
The observed characteristics of the attack are fully consistent with the phenomenon of Erosion-Corrosion (otherwise known as Flow-Assisted Corrosion or Impingement Corrosion). The clear observation of horseshoe shaped pits, with their open ends facing downstream, is classically diagnostic of Erosion-Corrosion.

Figure 7: Early stages of Erosion-Corrosion attack. Horseshoe-shaped pits have open end downstream.

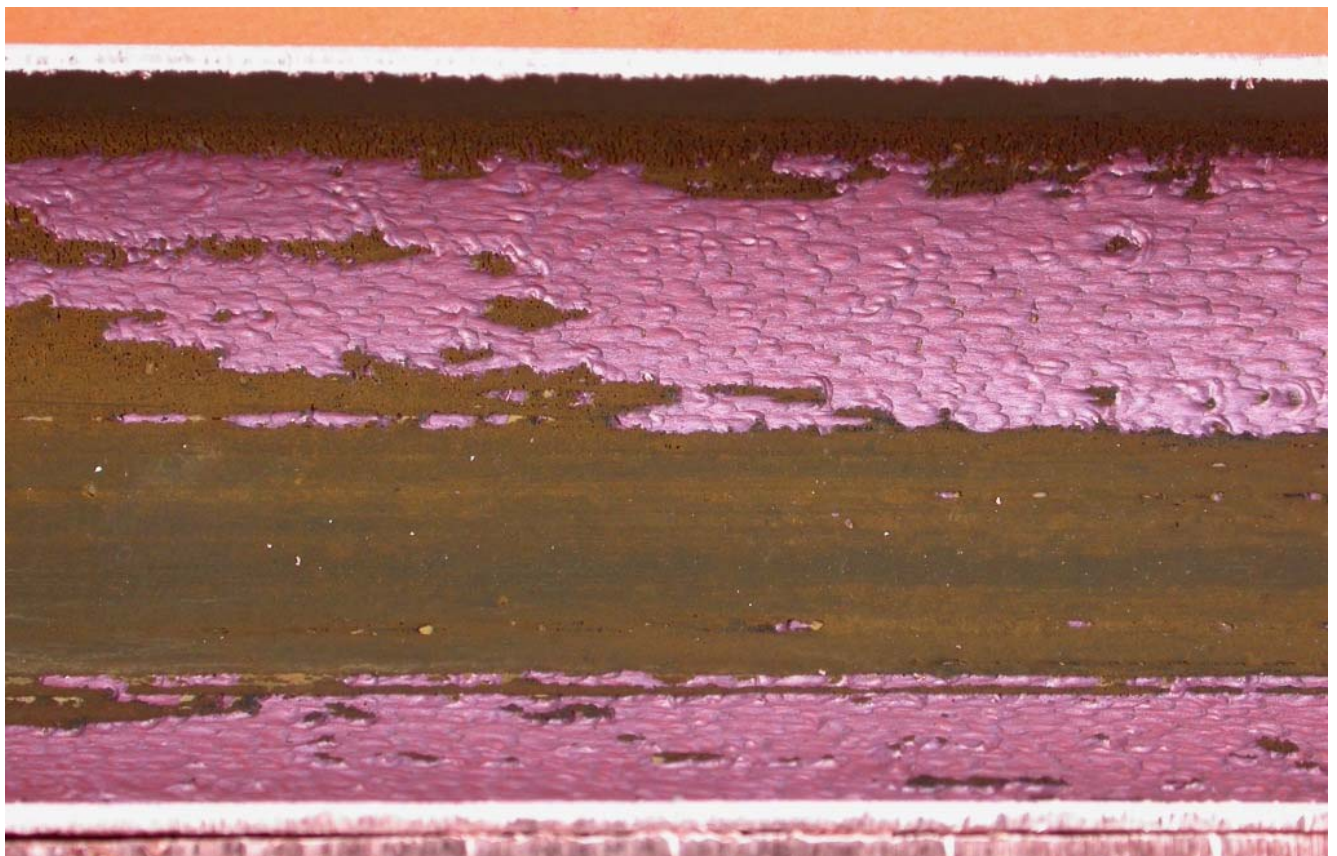
Figure 8: Large region of Erosion-Corrosion in straight section of pipe ~500 mm upstream of the bend. Many horseshoe-shaped pits, coalescing.

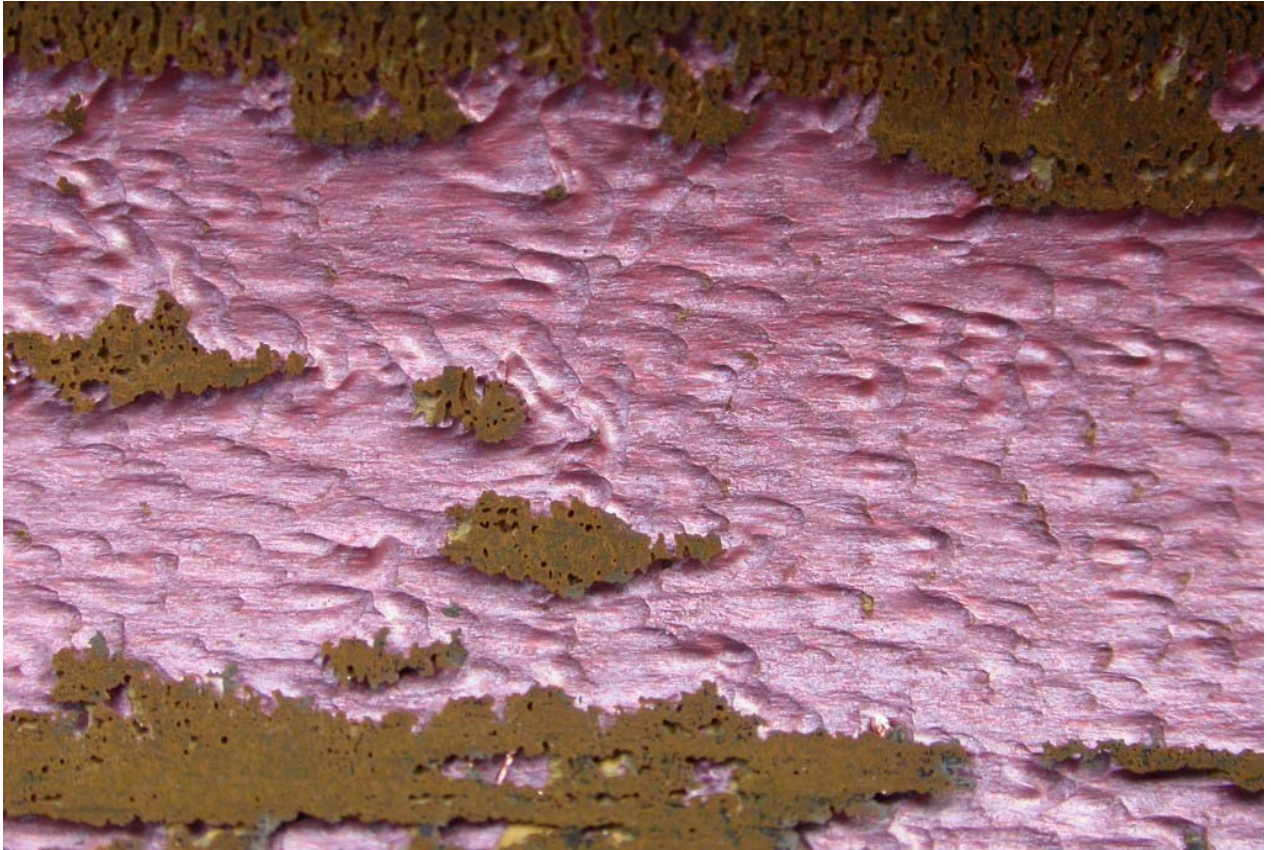
Figure 9(a): Further detail of Erosion-Corrosion, showing coalescence of horseshoe-shaped pits and islands of intact oxide. The latter are deeply undercut.

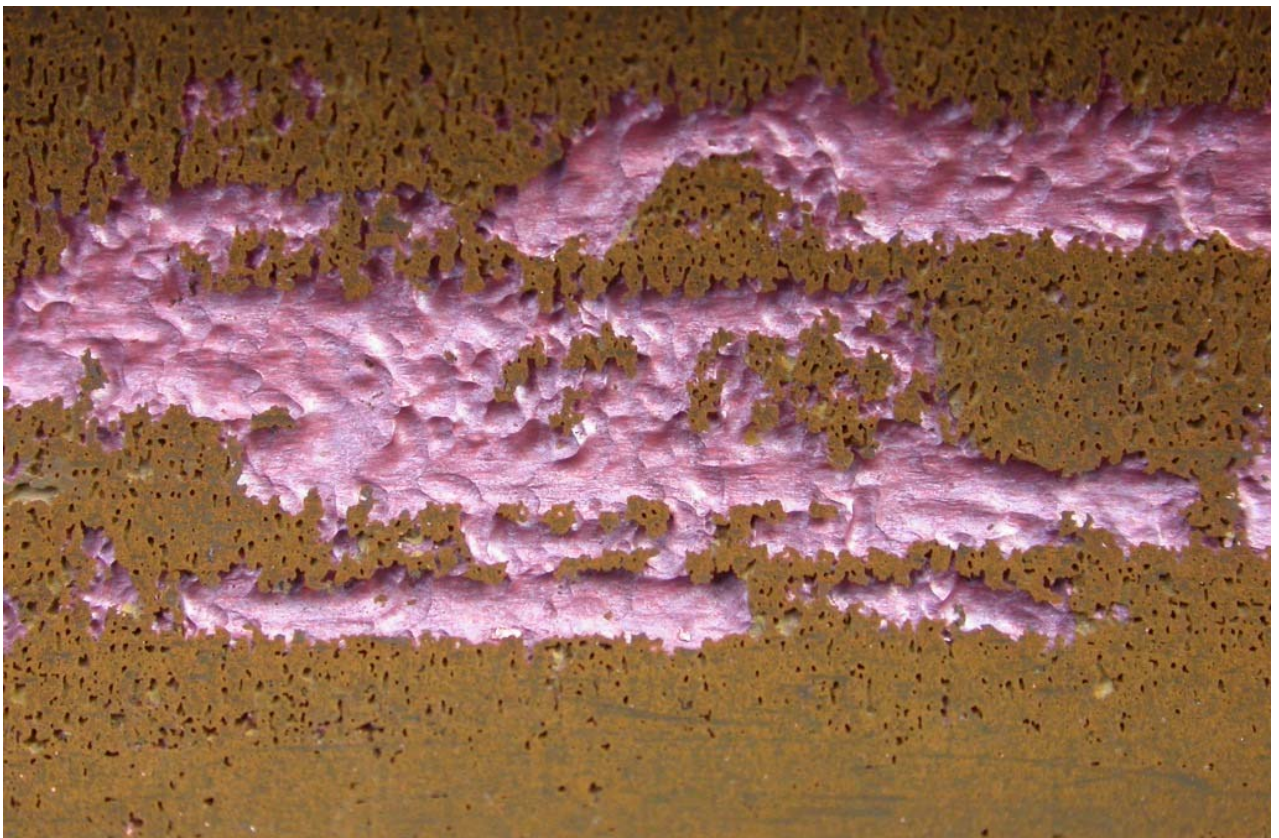
Figure 9(b): Further view of Erosion-Corrosion and undercut islands of intact oxide.

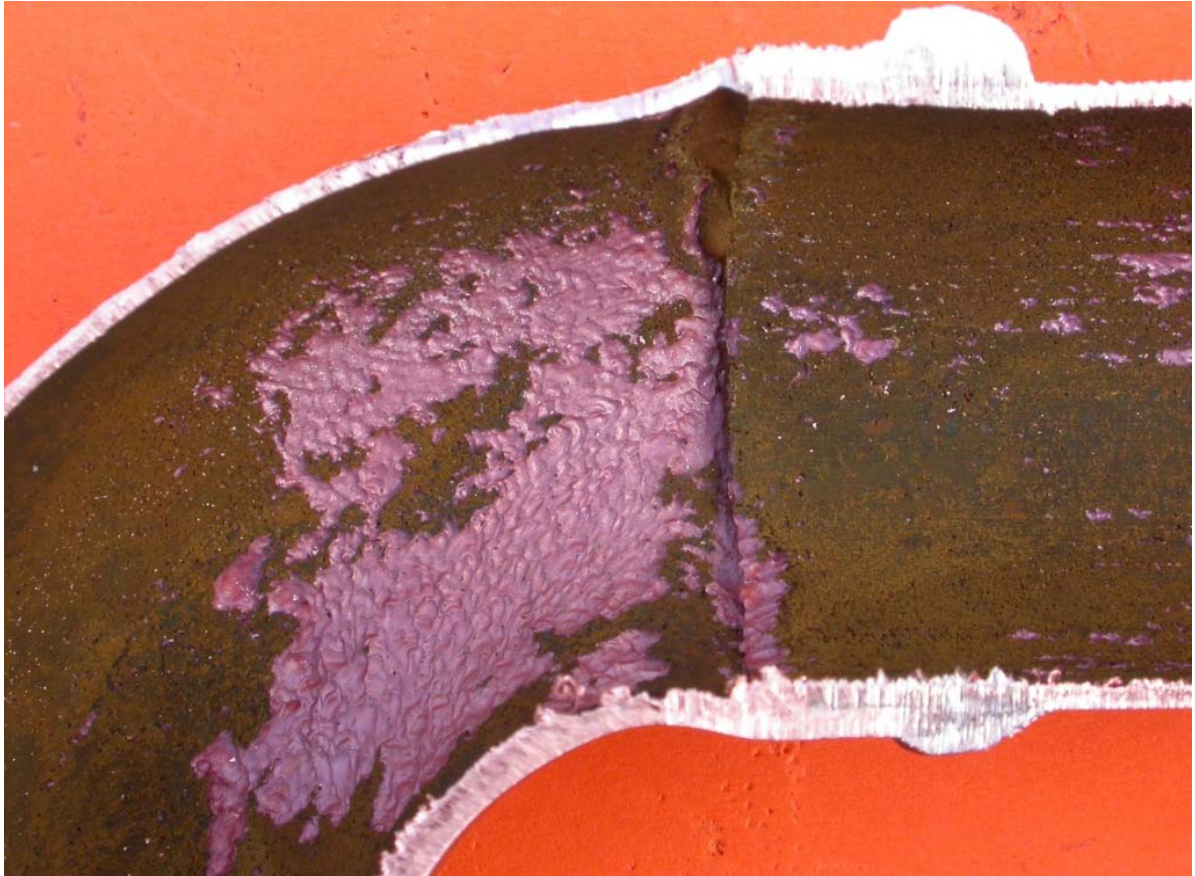
Figure 10(a): Erosion-Corrosion downstream of joint.

Figure 5, Figure 10 and Figure 11 above show that the Erosion-Corrosion occurs preferentially at and/or downstream of joints in the pipe. This is indicative of the results of turbulence created by the internal step at the joint. However, the attack shown in Figure 8 is not associated with any obvious source of turbulence.

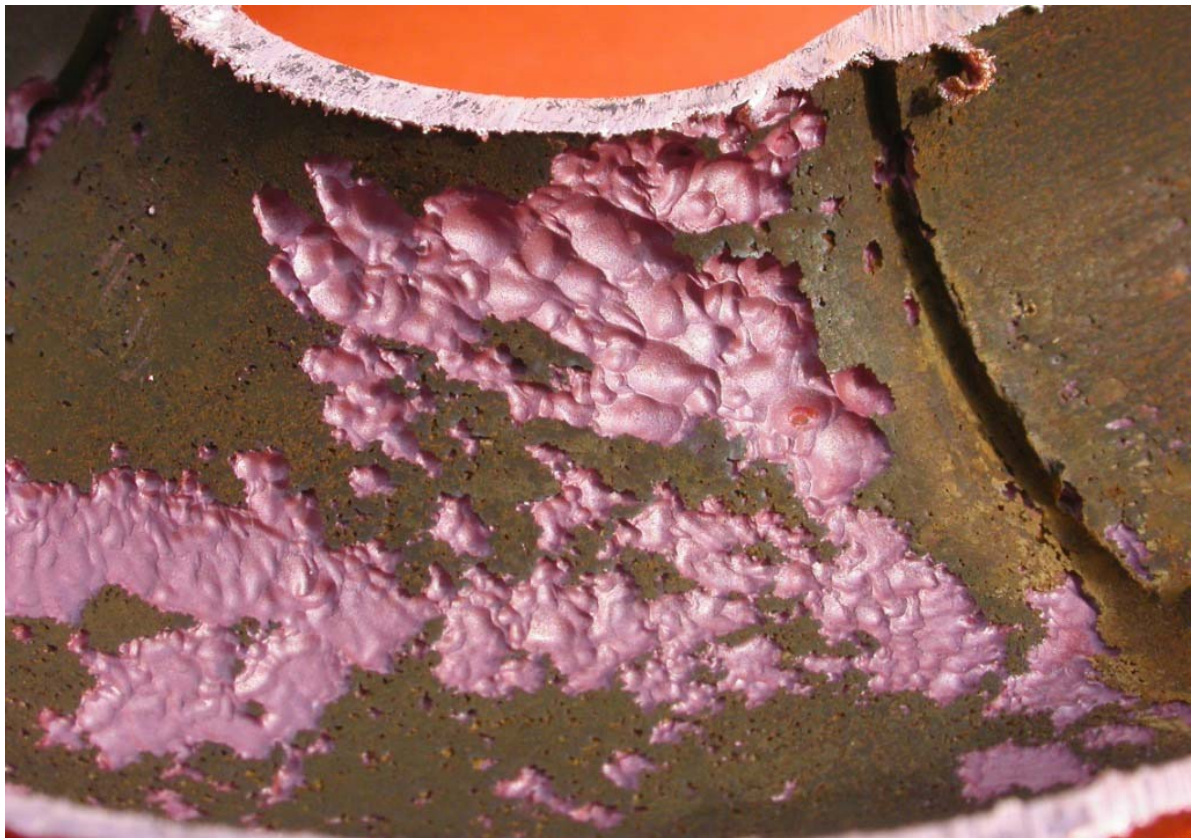
Figure 10(b): Erosion-Corrosion in bend downstream of joint.

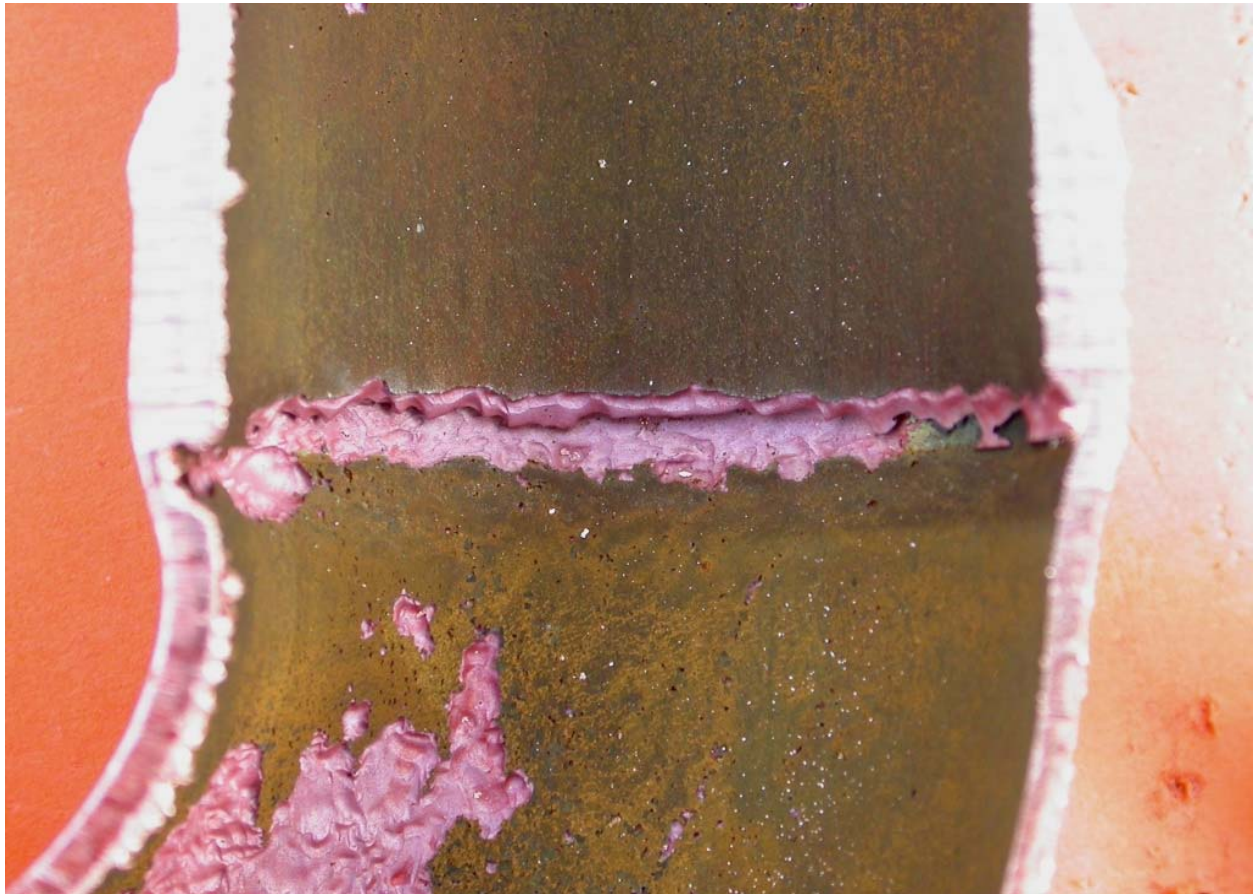
Figure 11(a): Erosion-Corrosion at joint, apparently promoted by turbulence at the joint.

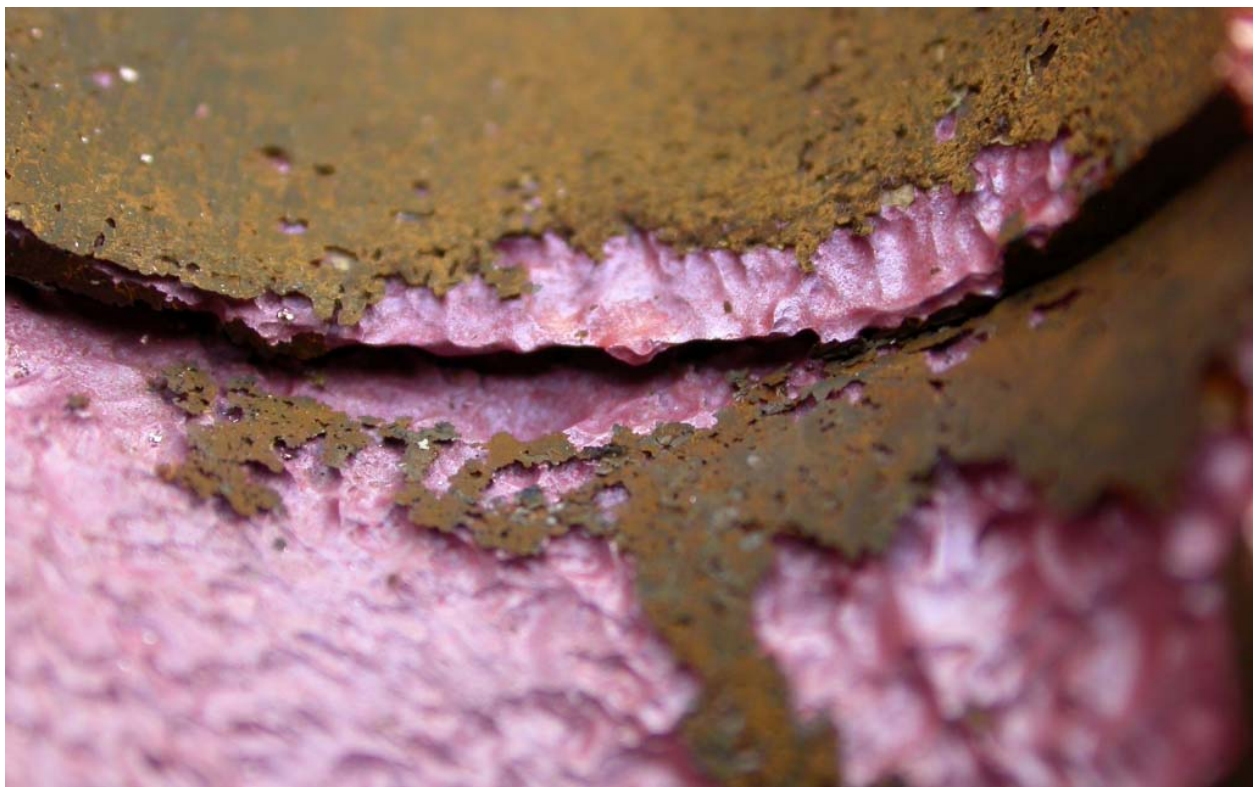
Figure 11(b): Erosion-Corrosion at joint, apparently promoted by turbulence at the joint.

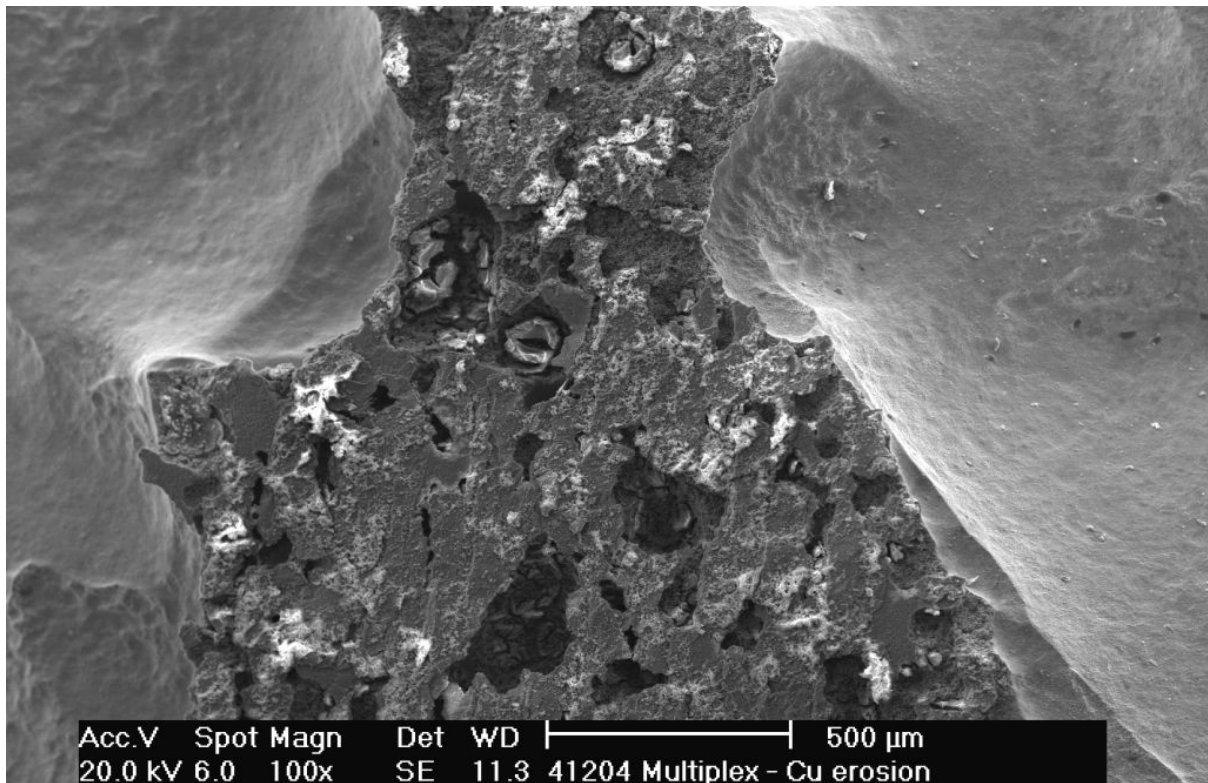
Figure 13 shows low-magnification SEM images from Sample B. The two images show an island of remaining protective oxide scale, with Erosion-Corrosion pits on either side. Figure 13(a) is a secondary electron image (SEI) and (b) is a backscattered electron image (BEI) of the same field of view. The SEI emphasises the topography, while the BEI gives information about the average atomic number (related to the atomic weight) of the chemical elements in the features on the surface. As a result of this “atomic number contrast”, the BEI in Figure 13(b) enables us to distinguish between oxide and metal. The bare metal in the pits appears brighter than the oxide, because the average atomic number of the oxide is lower than that of the metal. This confirms what has been assumed from the visual and optical microscope examination.

Figure 13(a): Sample “B” (within Bend). Low-magnification (100×) secondary electron image (SEI) of an island of protective oxide scale, with Erosion-Corrosion pits on either side.

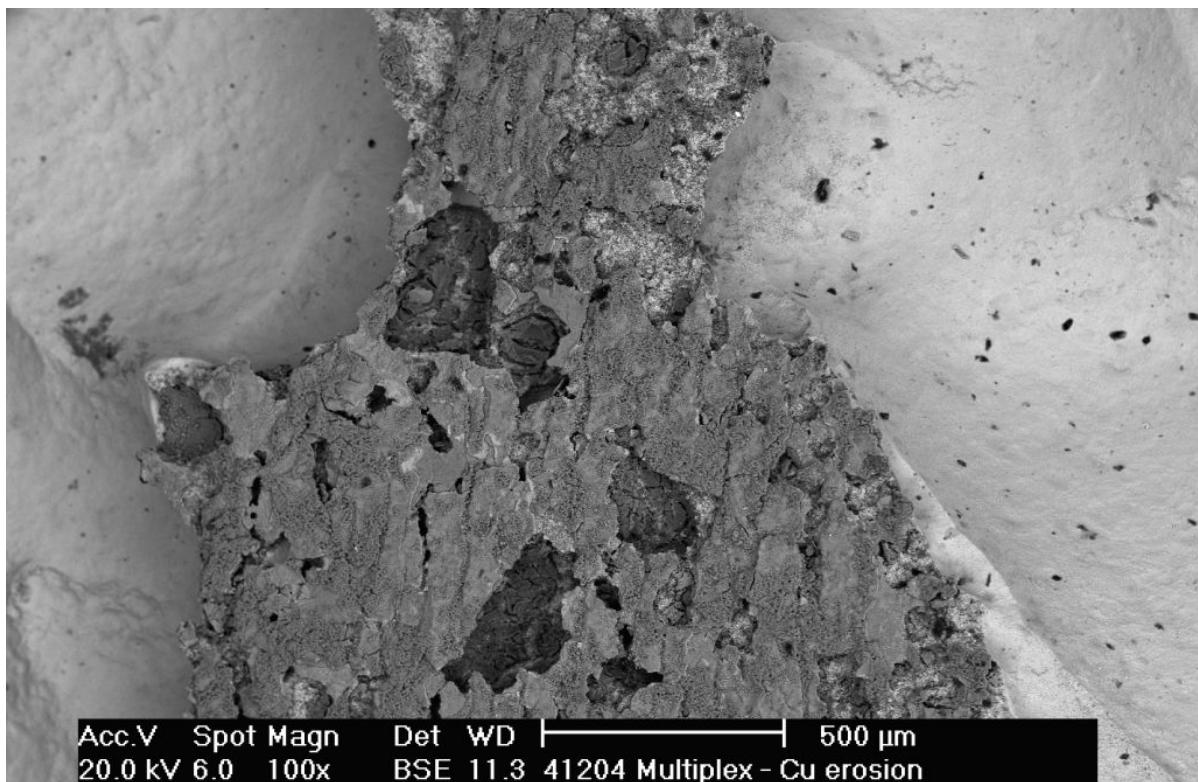
Figure 13(b): Backscattered electron image (BEI) of the same feature as shown in (a). The bare metal in the pits shows brighter than the oxide, because the average atomic number of the oxide is lower than that of the metal.

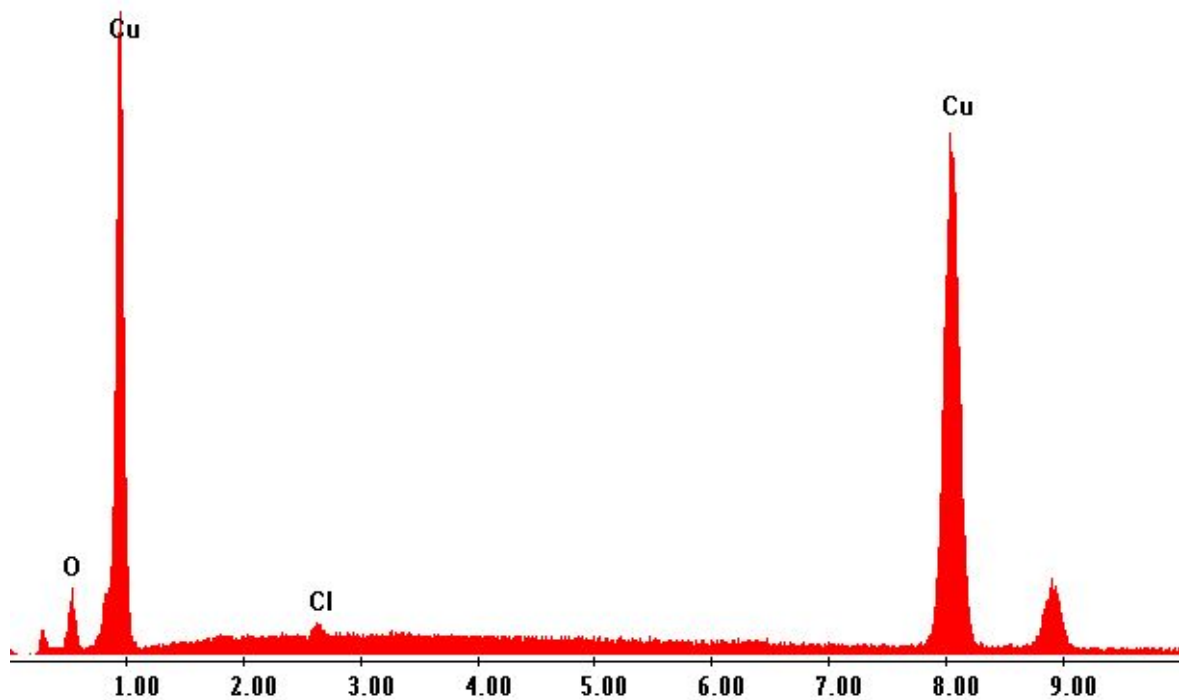
Label A: UQMP 41204 Multiplex - Cu erosion - Sample B, bare metal

Figure 14(a): Typical EDS spectrum from a bare metal region.

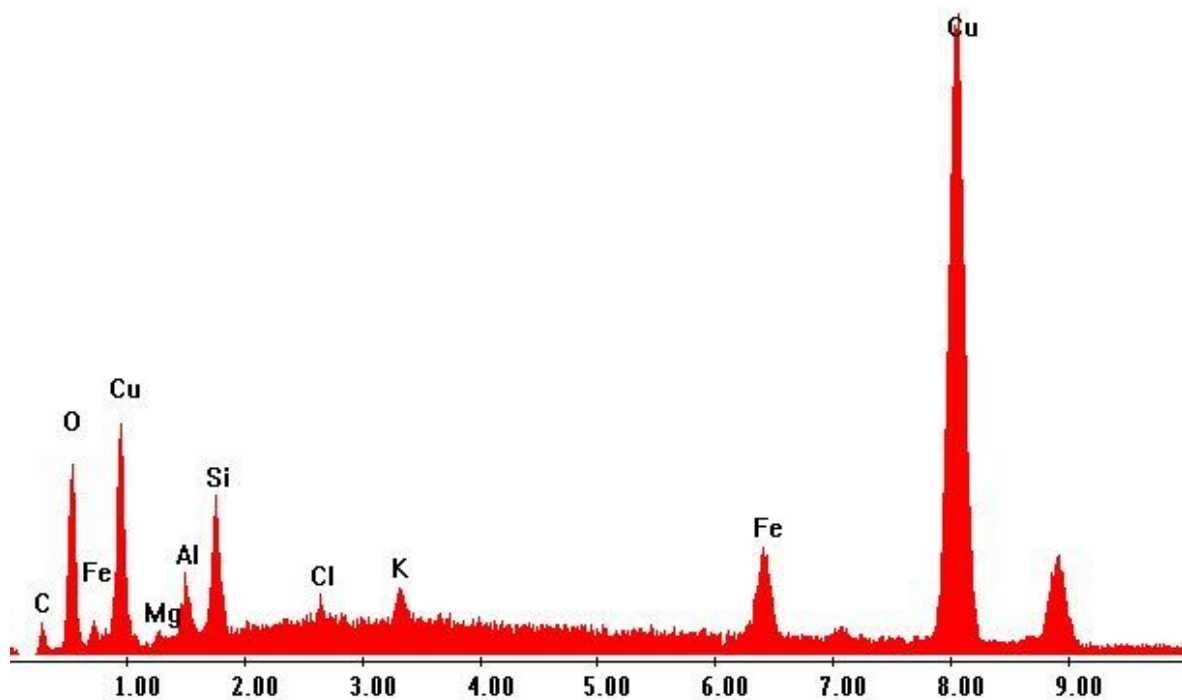
Label A: UQMP 41204 Multiplex - Cu erosion - Sample B, Oxide layer, low-Z region

Figure 14(b): EDS spectrum from a region of the original protective scale of corrosion products on the pipe surface.

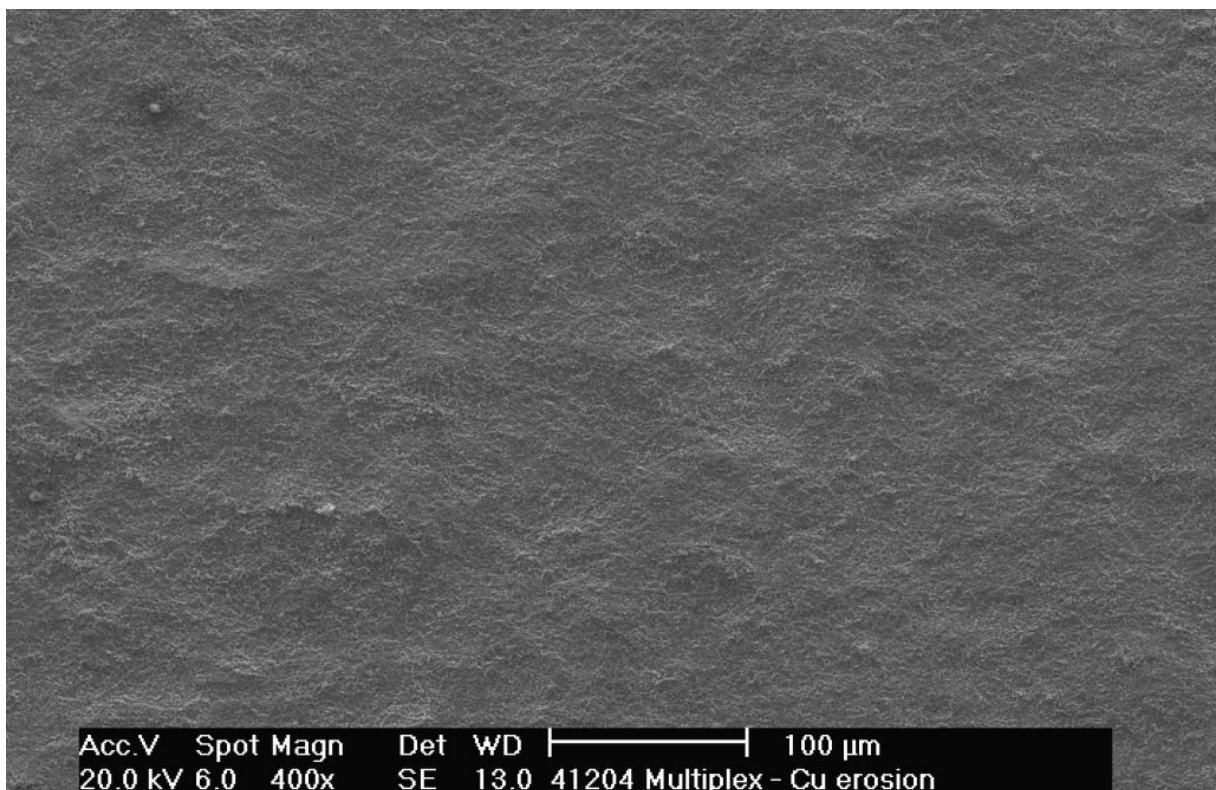
Figure 15(b): As per Figure 15(a) but at medium magnification (400×). Bare metal surface is flat and fairly featureless.

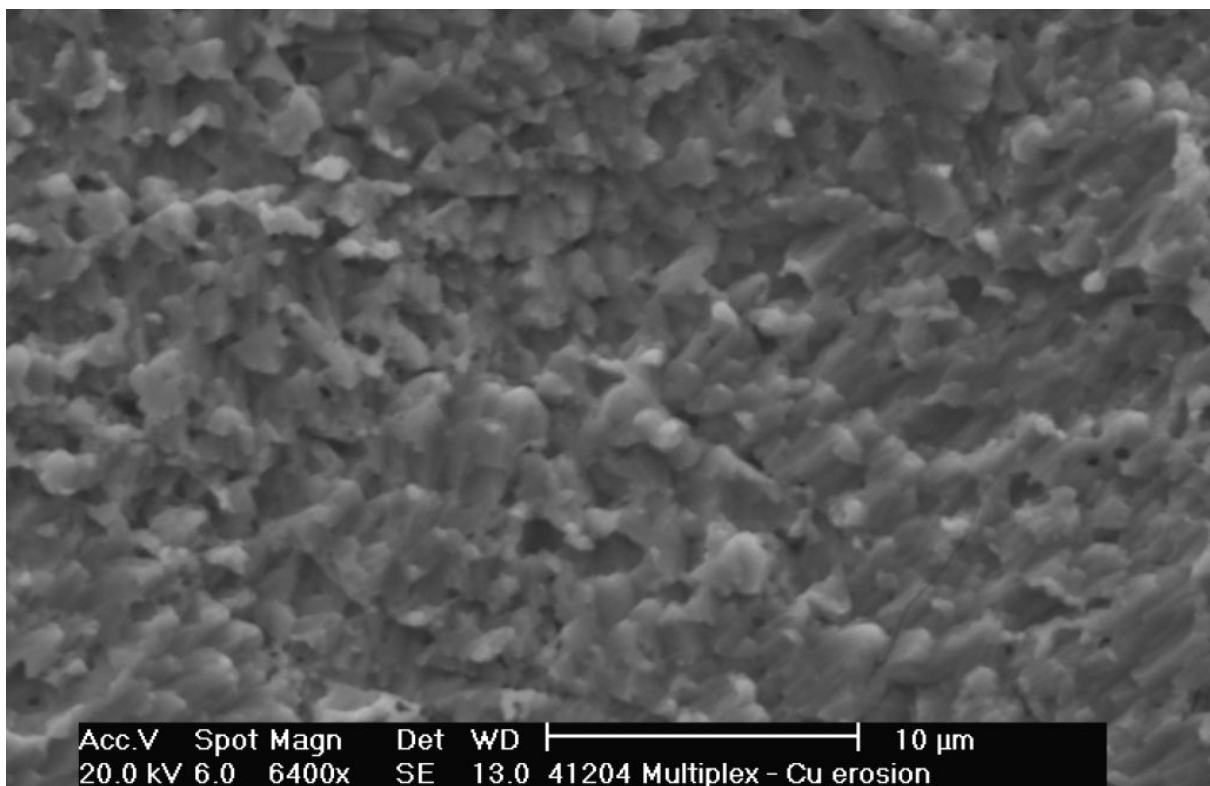
Figure 15(d): As per (a)–(c) but at high magnification (6400×). There are no obvious signs of solid particle erosion at low impingement angles (abrasive erosion), such as grooves or embedded mineral particles. Surface features could be consistent with active corrosion alone.
