Project No.: 41204

Subject: Leaks in Copper Pipe at Shafston Mansions

Date: 30 October, 2008

Leaks in Copper Pipe at Shafston Mansions

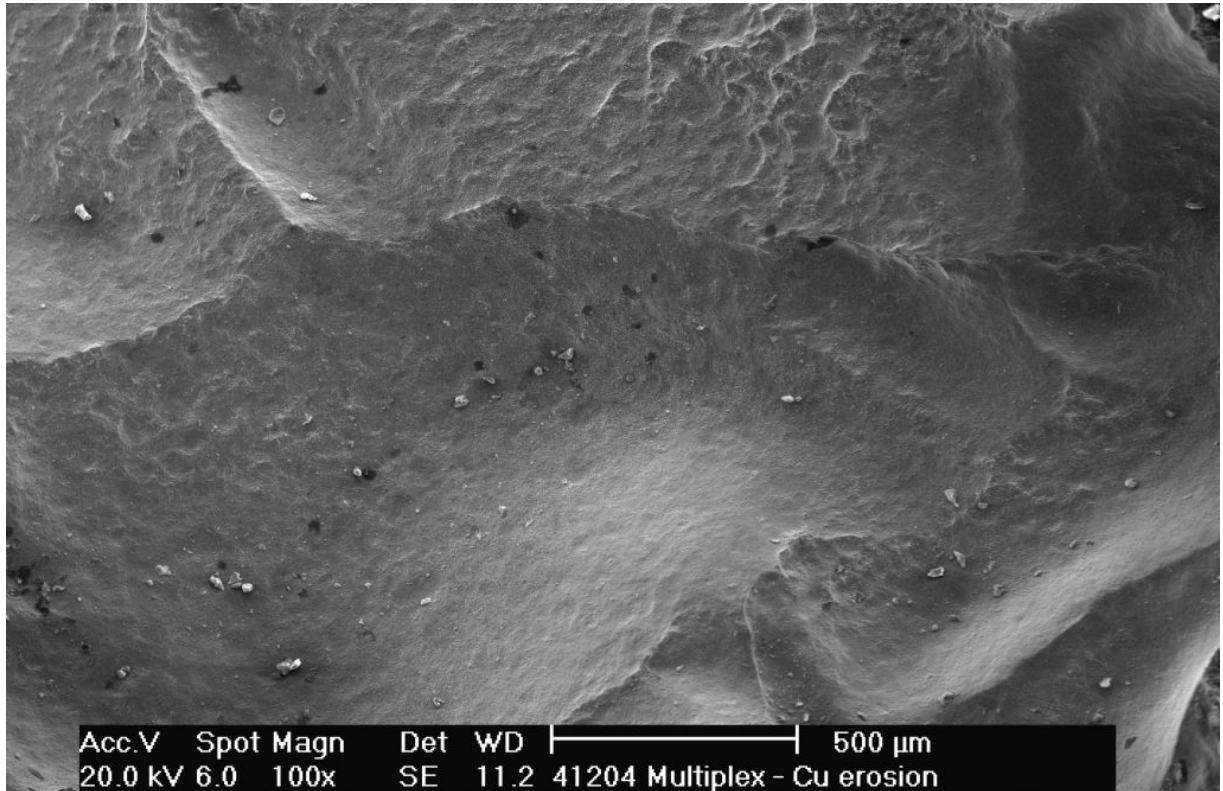
Figure 16(a) to (d) is again a series from 100× to 6400×, this time showing sample B. The low magnification image (a) shows the rough scalloped surface resulting from turbulent flow in the bend. Figure 16(b) to (d) show one of the “hill” regions within (a). The surface features are broadly similar to those seen in sample D, except that there are several small patches of smoother material. It is difficult to know what has caused these smoother patches, but they are not suggestive of Solid Particle Erosion.

Figure 16(a): Sample “B” (within Bend). Low-magnification (100×) secondary electron image of the rough scalloped surface resulting from turbulence in the bend. Some debris particles.

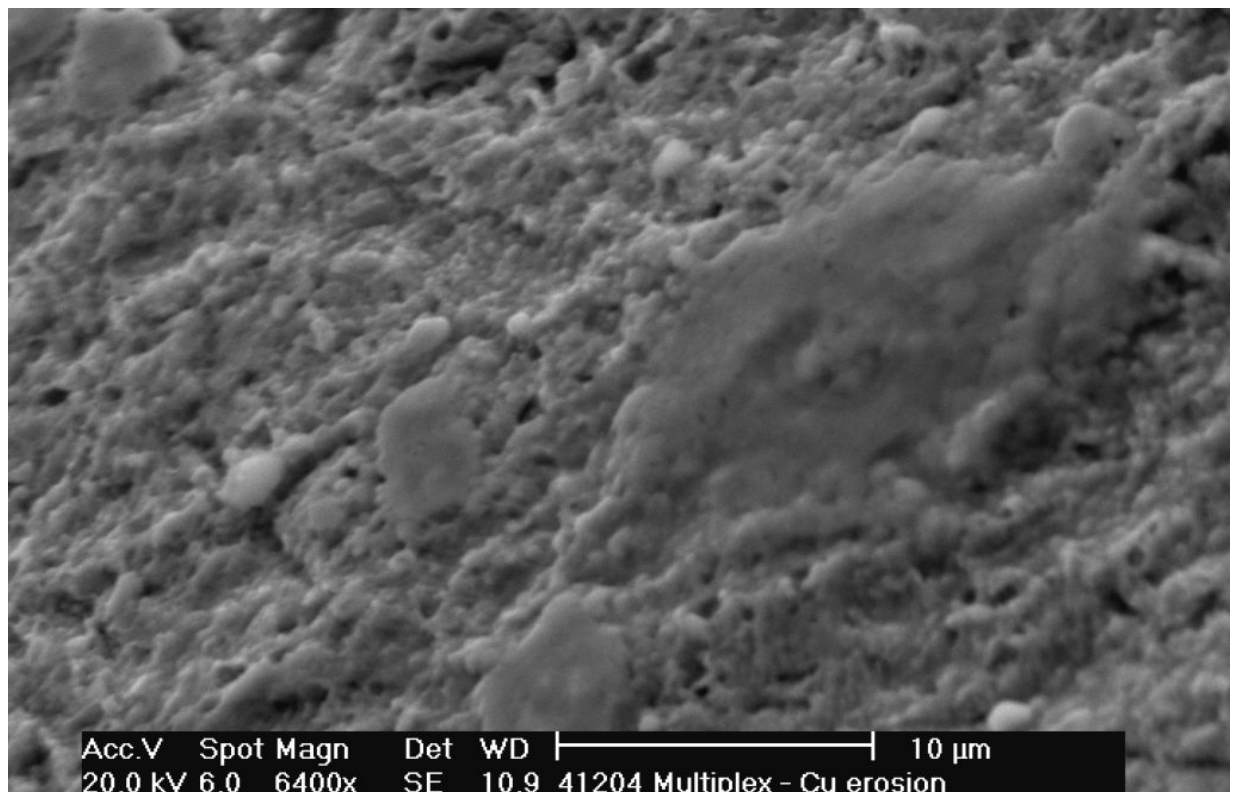
Figure 16(d): As per (a)–(c) but at high magnification (6400×). Once again there are no signs of solid particle erosion. EDS analysis shows that essentially all of the surface (including both rougher and smoother features in this image) is metallic copper.

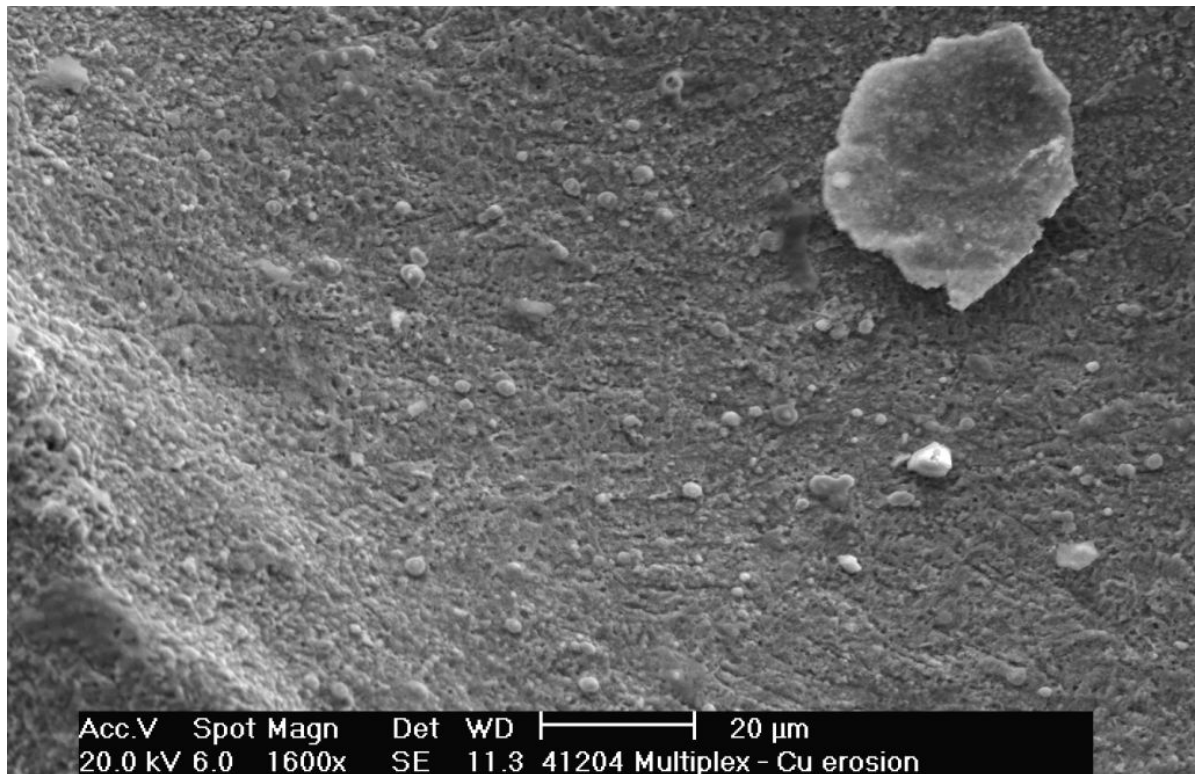
Figure 17(a) and (b) are from a valley region within Figure 16(a). In the lower portion of the field of view in Figure 17(a) there are some fine roughly linear striations. The striations are some 12–15 µm long, and there are 10 or more of them, approximately parallel to each other. It is difficult to judge what is likely to have caused these linear features. It is conceivable that they might be the remnants of grooves from abrasive particles (subsequently affected by corrosion). Alternatively they could represent preferential corrosion of some directional feature in the copper microstructure, such as twinning. I have some experience with examination of surfaces damaged by Solid Particle Erosion, but am not able to make a confident judgement in this case.

Figure 17(a): Region within valley to left of centre in upper portion of Figure 16(a), at medium-high magnification (1600×). Debris includes some small mineral particles and a ~30 µm flake of metallic copper.

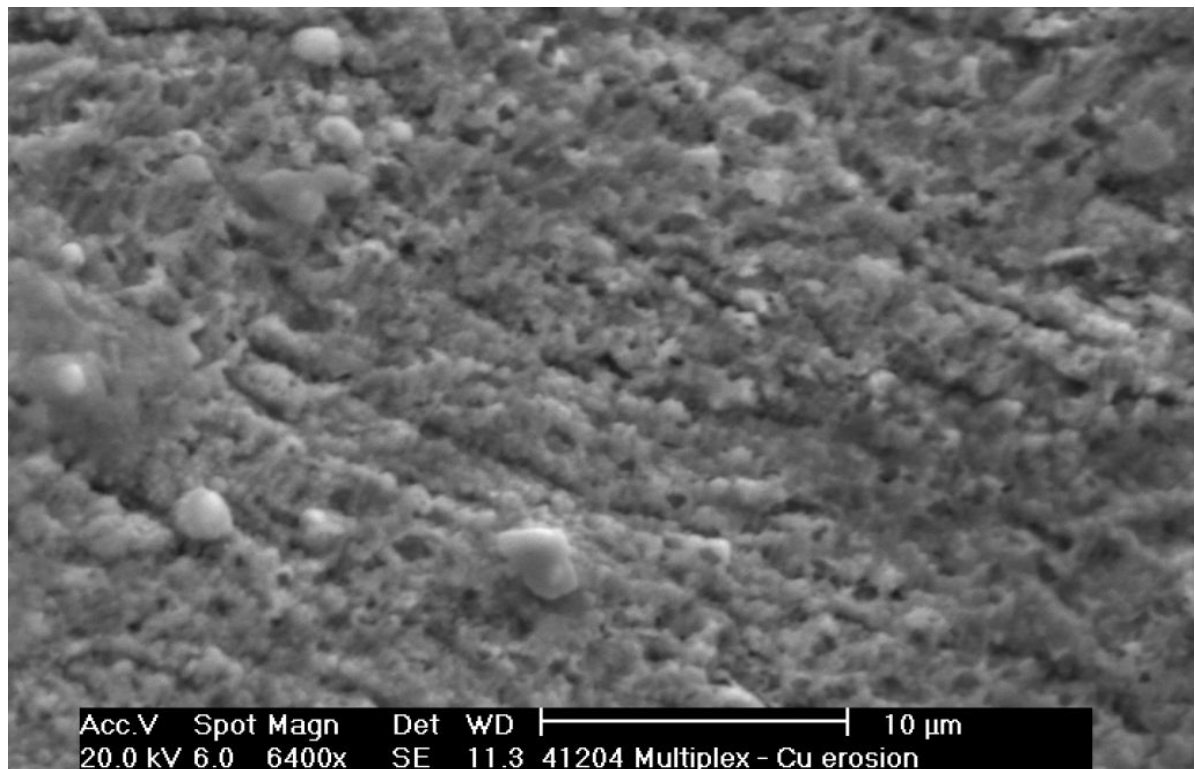
Figure 17(b): High magnification image from lower portion of Figure 17(a). It is difficult to judge whether or not these striations represent evidence for Solid Particle Erosion effects.
