Project No. 41994

Subject: **Erosion-Corrosion of Copper Pipes in Hot Water
Reticulation Systems —
Case Studies and Wider Implications**

Date: 7 July 2014

Prepared By: **J.D. Gates**, BSc(Hons), PhD, CPEng, NPER, RPEQ, CMatP

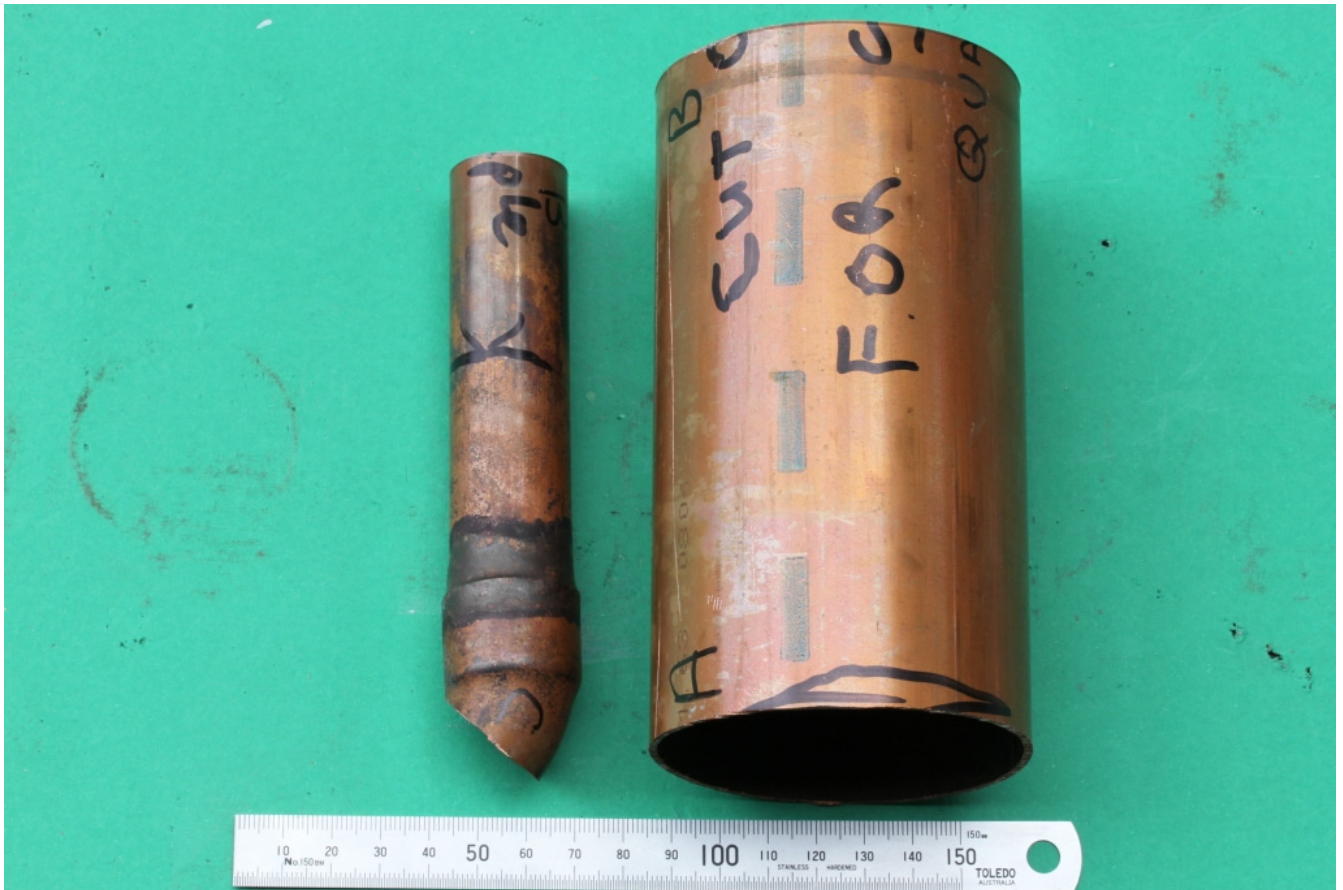
Two tube samples were provided to UQMP — one large diameter and one small diameter (see Figure 3 below). The smaller diameter tube showed clear evidence of Erosion-Corrosion (see Figure 4 and Figure 5). Characteristic features of Erosion-Corrosion seen in this sample included:

The larger diameter tube had no obvious signs of either Erosion-Corrosion or Pitting Corrosion.

Figure 3: Jacksons Landing, Quarry Building — Samples provided for examination.

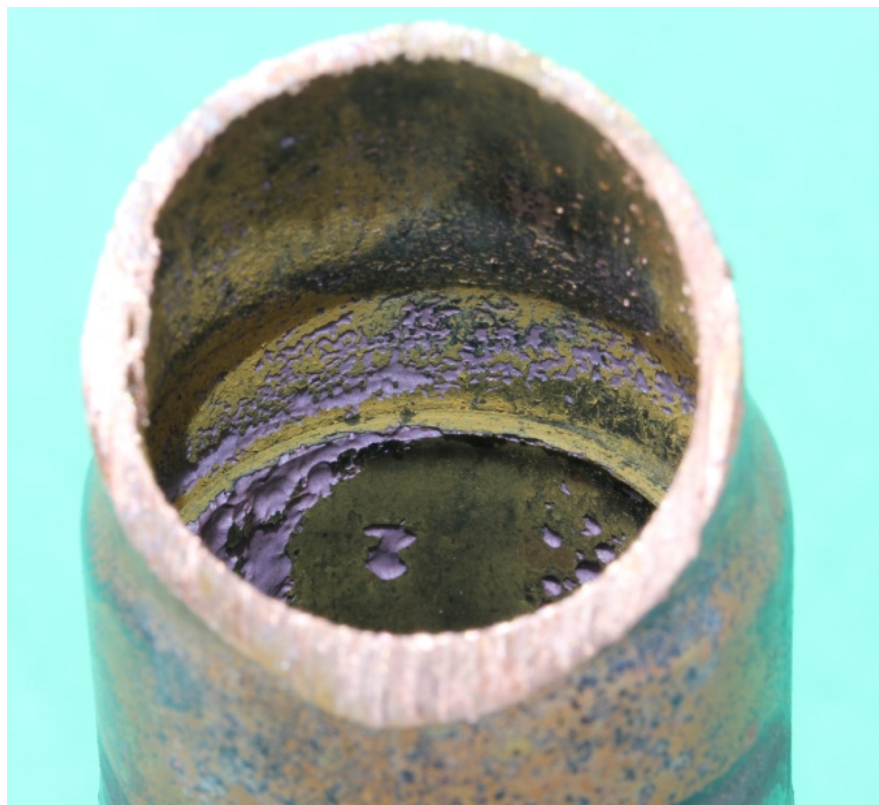
- Extensive regions of attack showing bare copper with no protective film;
- Islands of intact protective film, with undercutting;
- The regions of attack are associated with a joint which creates an internal step, hence turbulence;
- The joint also appears to be downstream from a bend in the tube.

*Figure 4(a): Jacksons Landing, Quarry Building — Smaller diameter tube before sectioning.
Evidence of Erosion-Corrosion visible from the open end.*

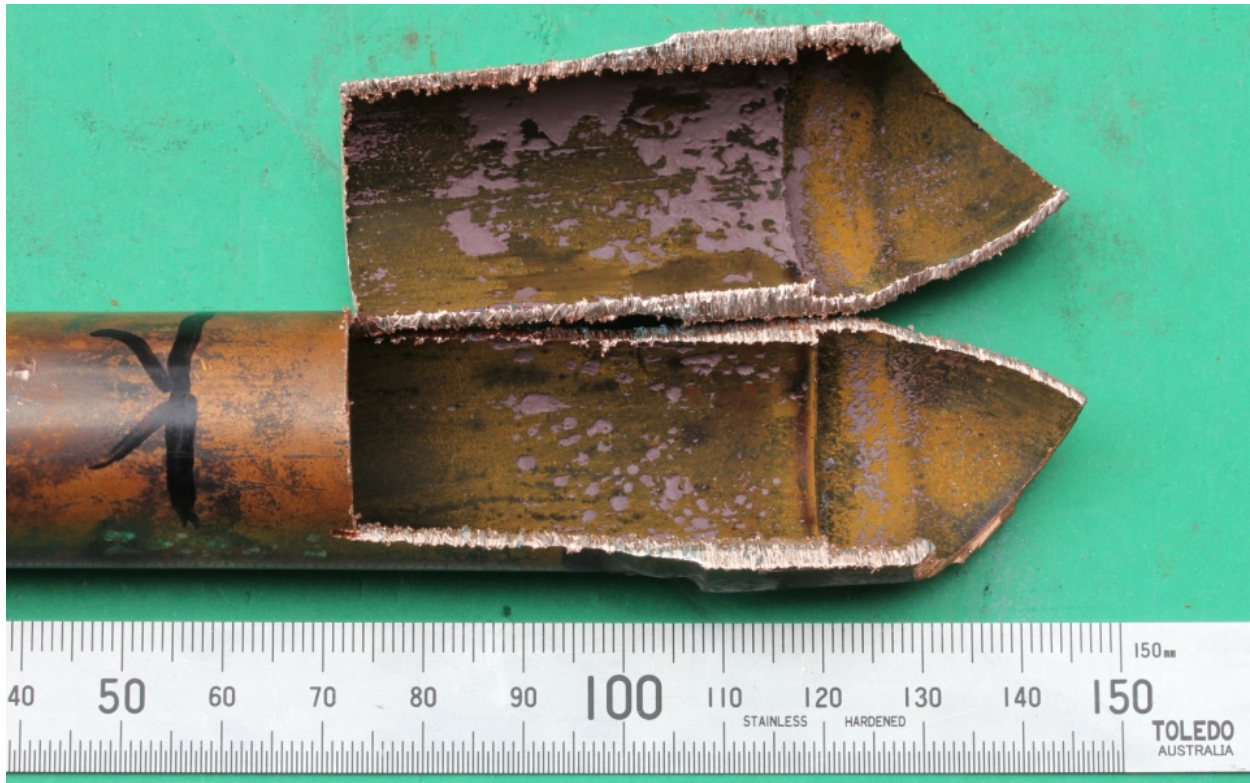
Figure 4(b): Quarry Building — Sample sectioned to reveal interior surfaces of tube.

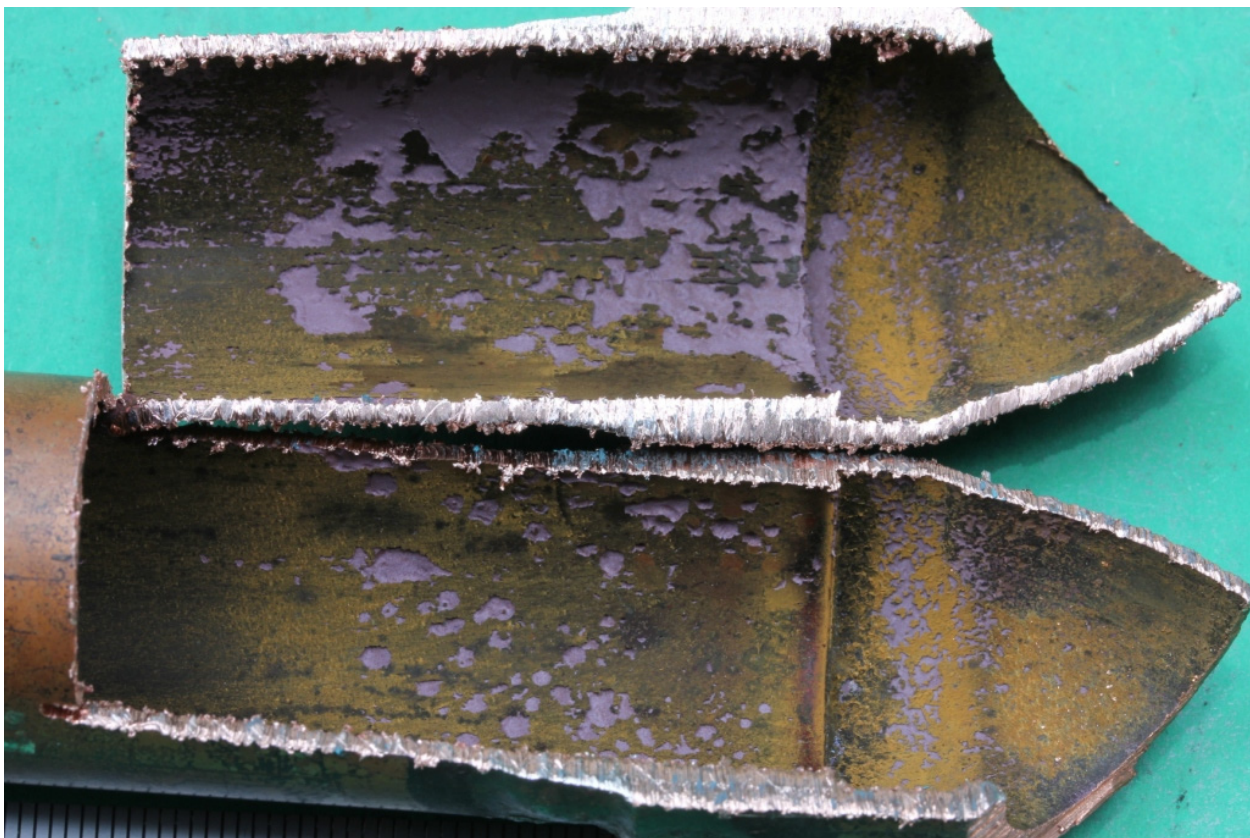
Figure 5: Jacksons Landing, Quarry Building — Closer view of Erosion-Corrosion attack on inner surface of tube; Extensive regions of bare metal in undercut pits and troughs between intact copper oxide scale; Distribution of attack suggests the role of turbulence associated with the joint.

The examination of the provided samples revealed one case of severe Erosion-Corrosion. The occurrence of even one example of Erosion-Corrosion of this level of severity raises a strong suspicion that water velocities are too high in the system.

To conduct a reliable assessment of the condition of the copper tubes in the recirculating hot water systems at the Jacksons Landing site, and to judge whether or not the excessive water velocities represent a systemic problem at the site, would require access to a larger number of samples of tubes of the high-risk type.

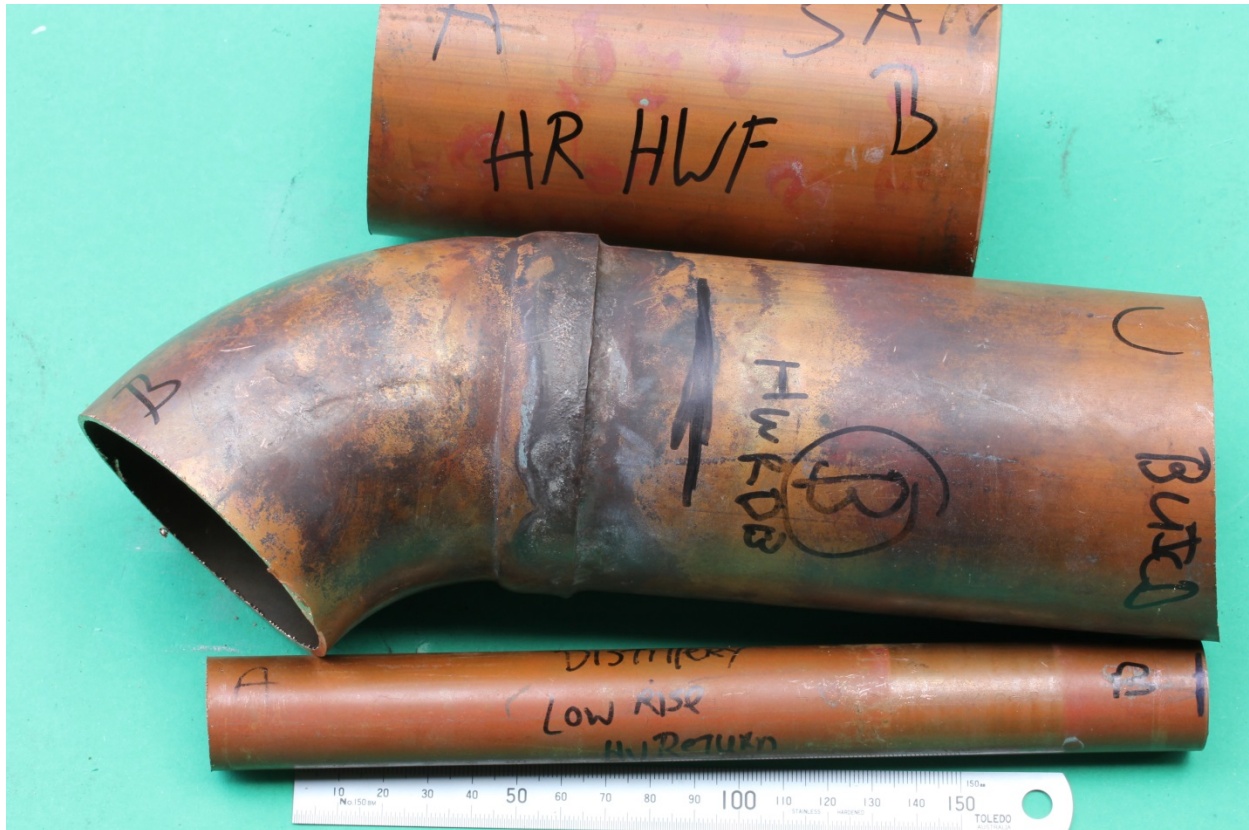
Three samples were provided, two large diameter and one small (see Figure 6). The small diameter tube was a straight section with neither bends nor joints.

None of the three samples showed any obvious signs of Pitting Corrosion or Erosion-Corrosion.

Figure 6: Jacksons Landing, Distillery Building — Samples provided for examination.

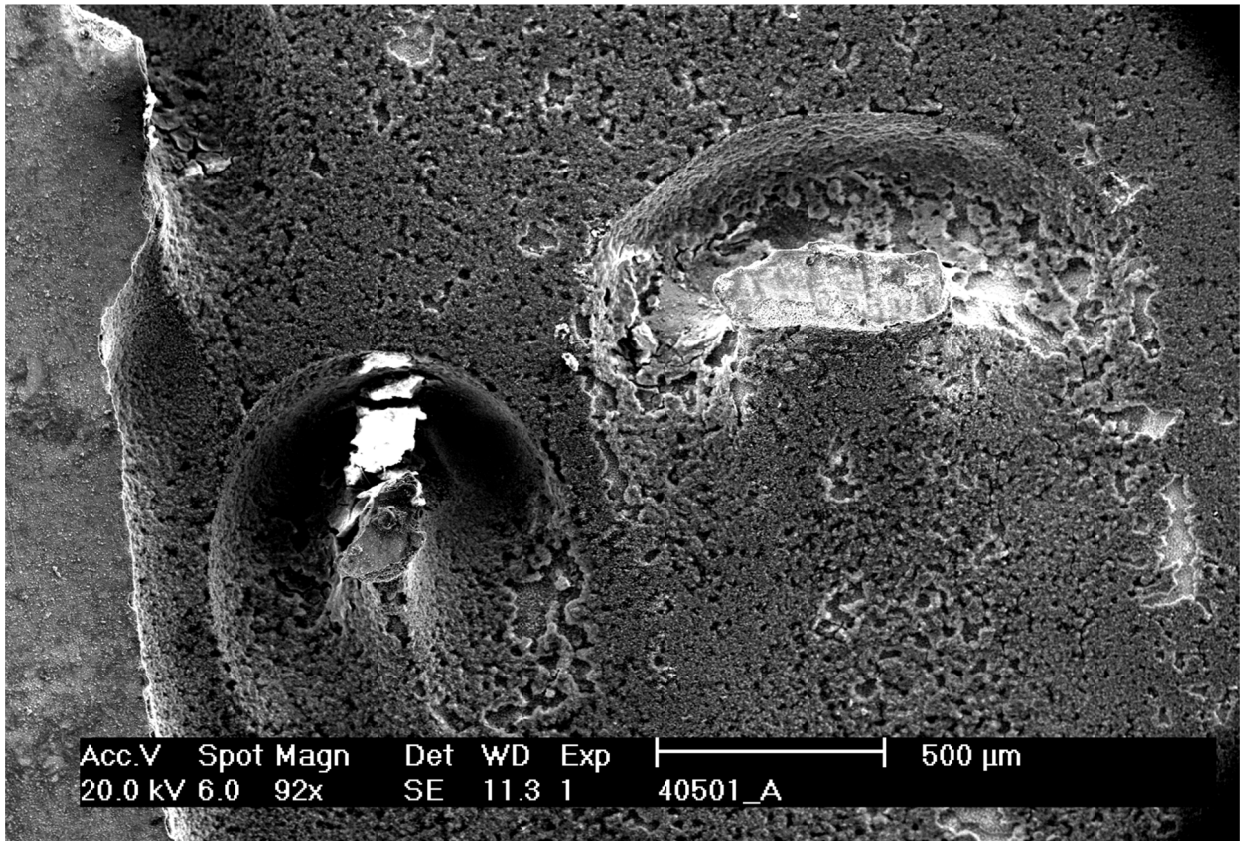
- (a) Extensive regions of pitting, clearly exposing the bare copper.
- (b) Deep, undercut, longitudinal geometry of troughs and pits. The longitudinal orientation and undercutting are recognised characteristics of Erosion-Corrosion, resulting from the action of fluid flow in the pipe.

- (c) Many of the pits having a characteristic horseshoe shape. Horseshoe-shaped pits (with their open ends facing downstream) are a readily recognised diagnostic feature of Erosion-Corrosion, clearly indicating the importance of fluid flow in the mechanism.

The Erosion-Corrosion attack was most severe at poorly profiled joints, and at bends, but was not restricted to these locations. UQMP was not informed of the water velocities or temperatures, but the widespread nature of the Erosion-Corrosion attack indicated systemically excessive velocities and/or temperatures.

Figure 7(a): Nursing Home — Horseshoe-shaped pits within a longitudinal trough; Remaining scale-protected surface visible at left. SEM secondary electron image.

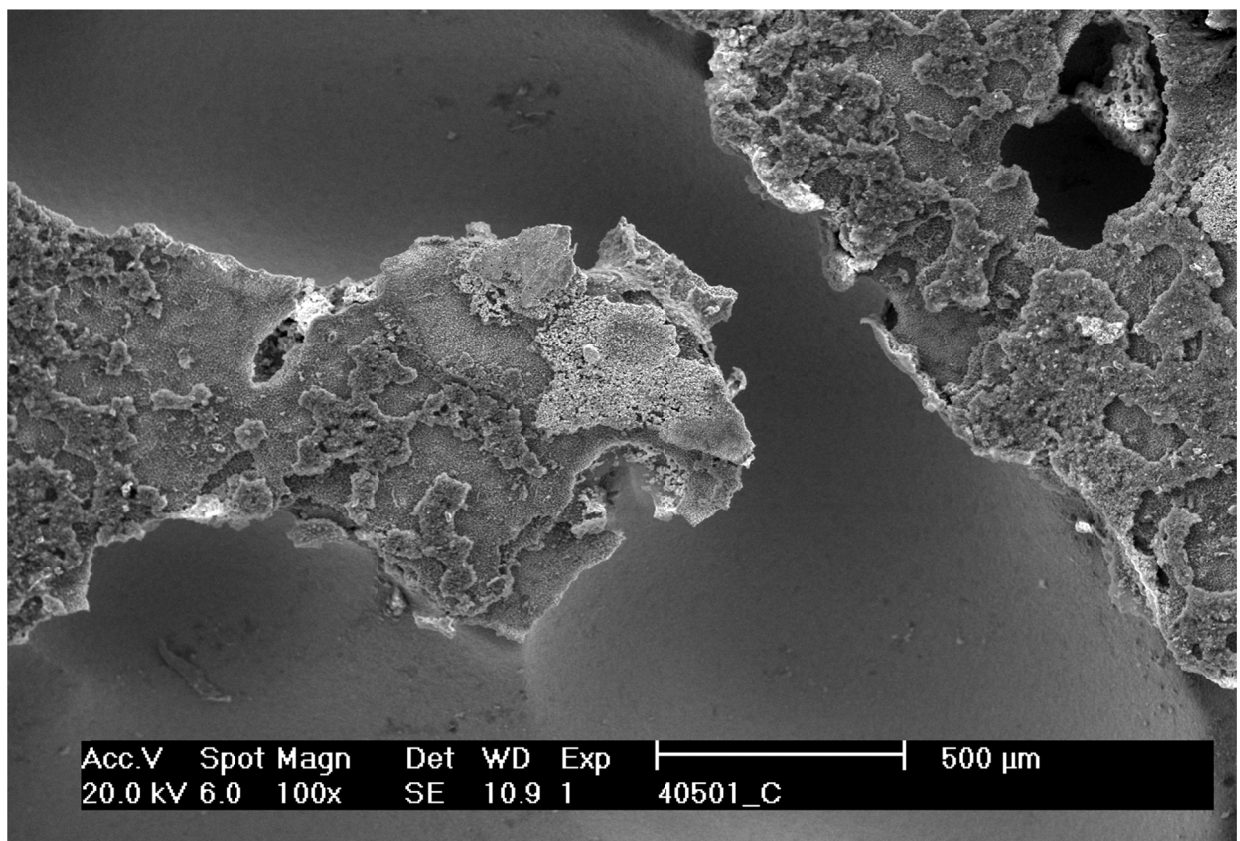
Figure 7(b): Nursing Home — Planar scale-protected surface and deeply undercut pits.

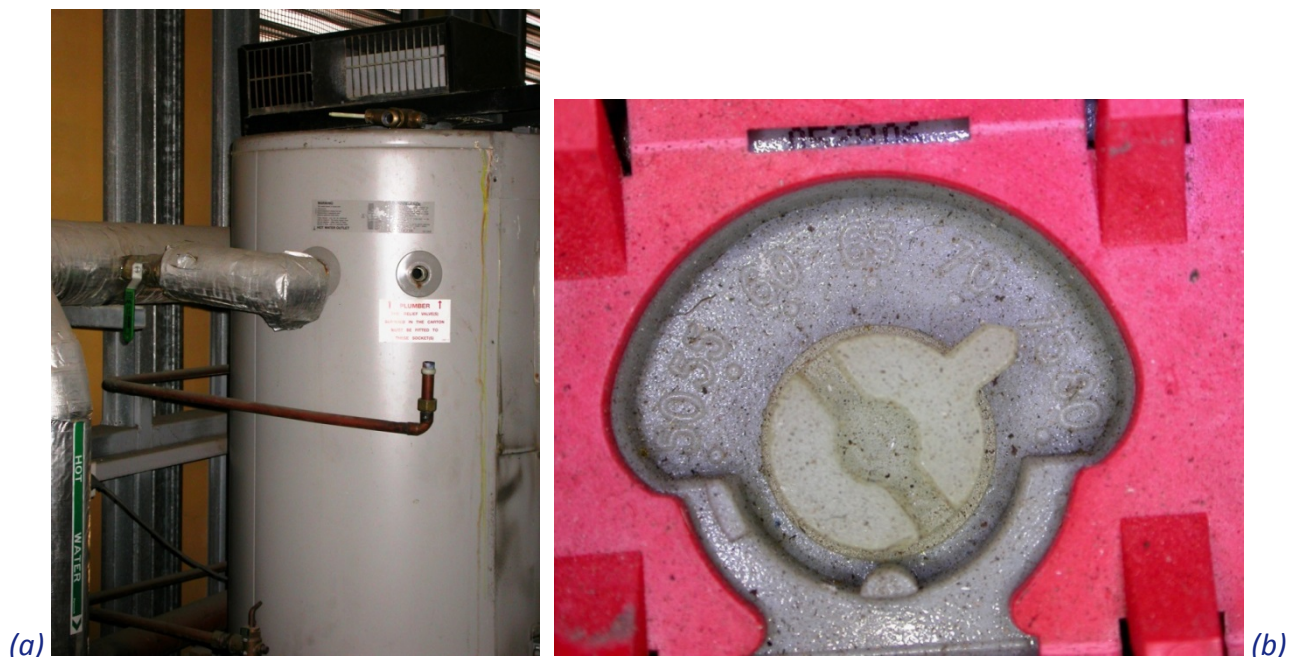
Figure 8(a) shows one of the water heaters. Figure 8(b) shows one of the temperature controllers, which appears to be set to about 73°C. From the seven water heaters that were operational at the time of inspection, outlet temperatures were measured to range from 54°C to 80°C.

Figure 8: Brisbane residential tower water heater and temperature controller. The controller appears to be set to about 73°C.

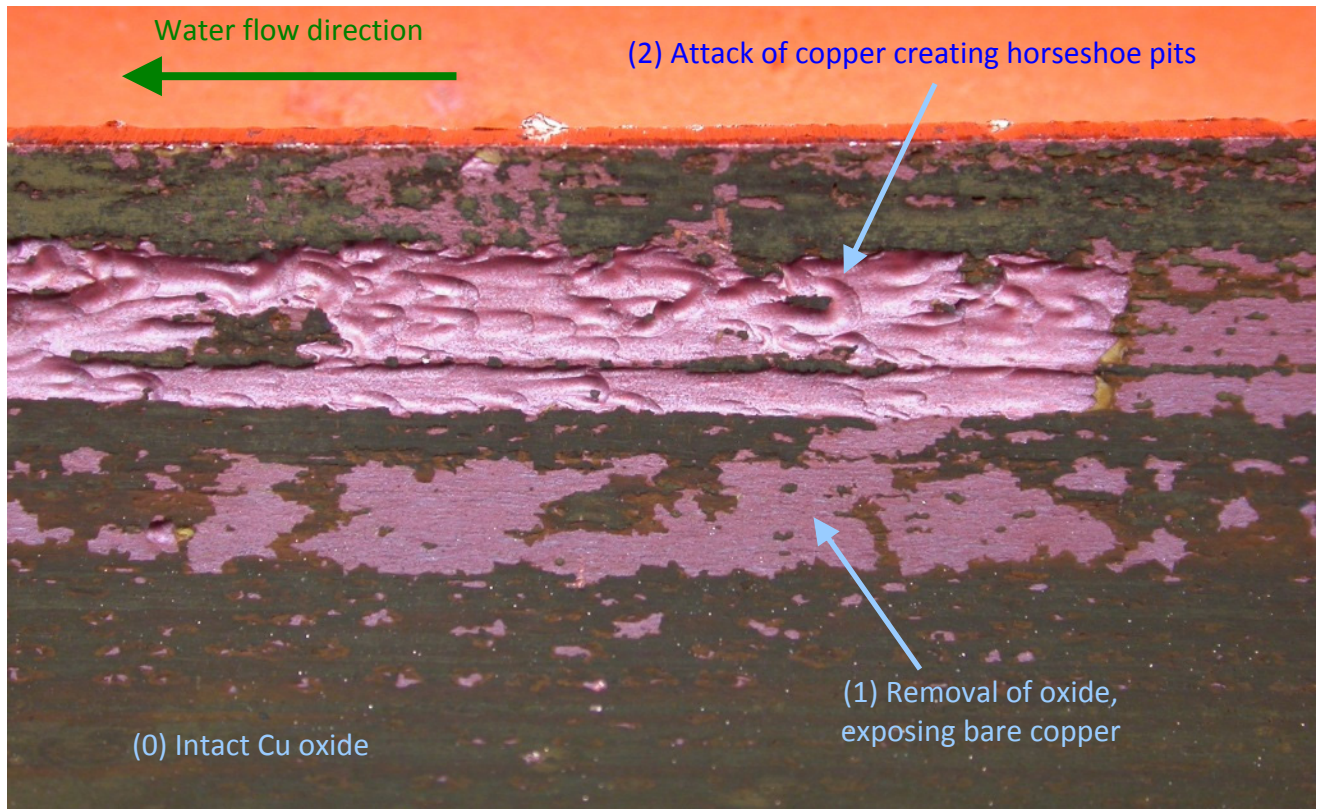
Figure 9(a): Brisbane residential tower — Early stages of Erosion-Corrosion attack; Horseshoe-shaped pits have open end downstream.

- (a) Extensive corroded regions showing bright metal surfaces, free from oxide scales.
- (b) Deep, undercut, longitudinal geometry of troughs and pits.

- (c) Horseshoe-shaped pits with their open ends facing downstream.
- (e) Absence of tubercles of corrosion products covering the pits.
- (f) Clear observation that the damage occurred preferentially (though not exclusively) at obvious sources of turbulence such as joints creating an internal step in the pipe.

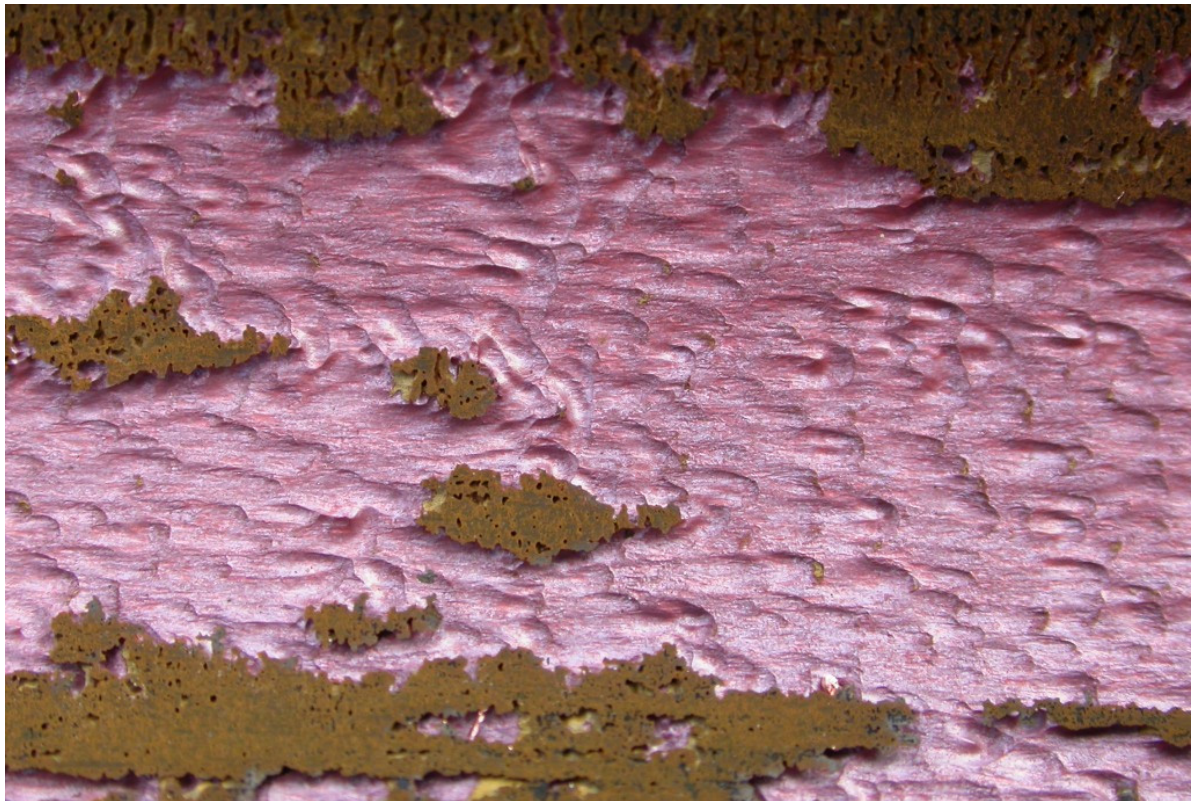
Figure 9(b): Brisbane residential tower — Detail of Erosion-Corrosion, showing coalescence of horseshoe-shaped pits, undercutting islands of intact oxide/carbonate/sulphate.

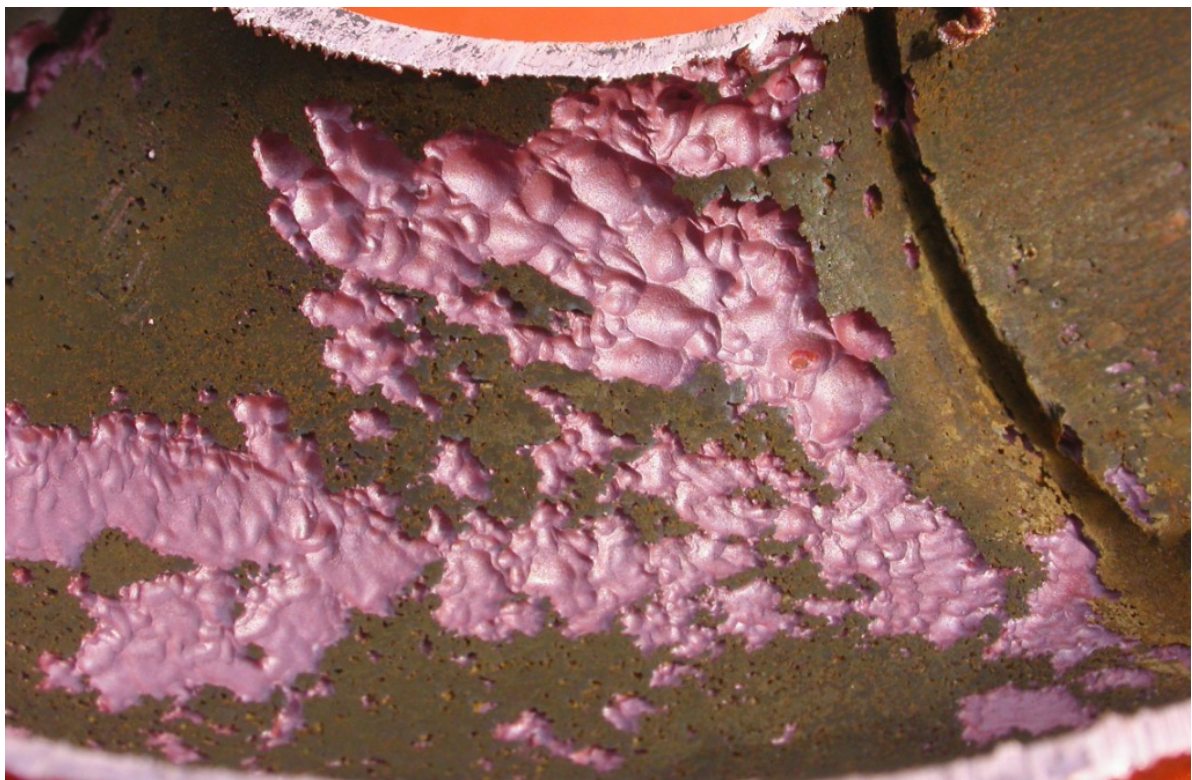
Figure 9(c): Brisbane residential tower — Erosion-Corrosion associated with turbulence downstream of a joint.

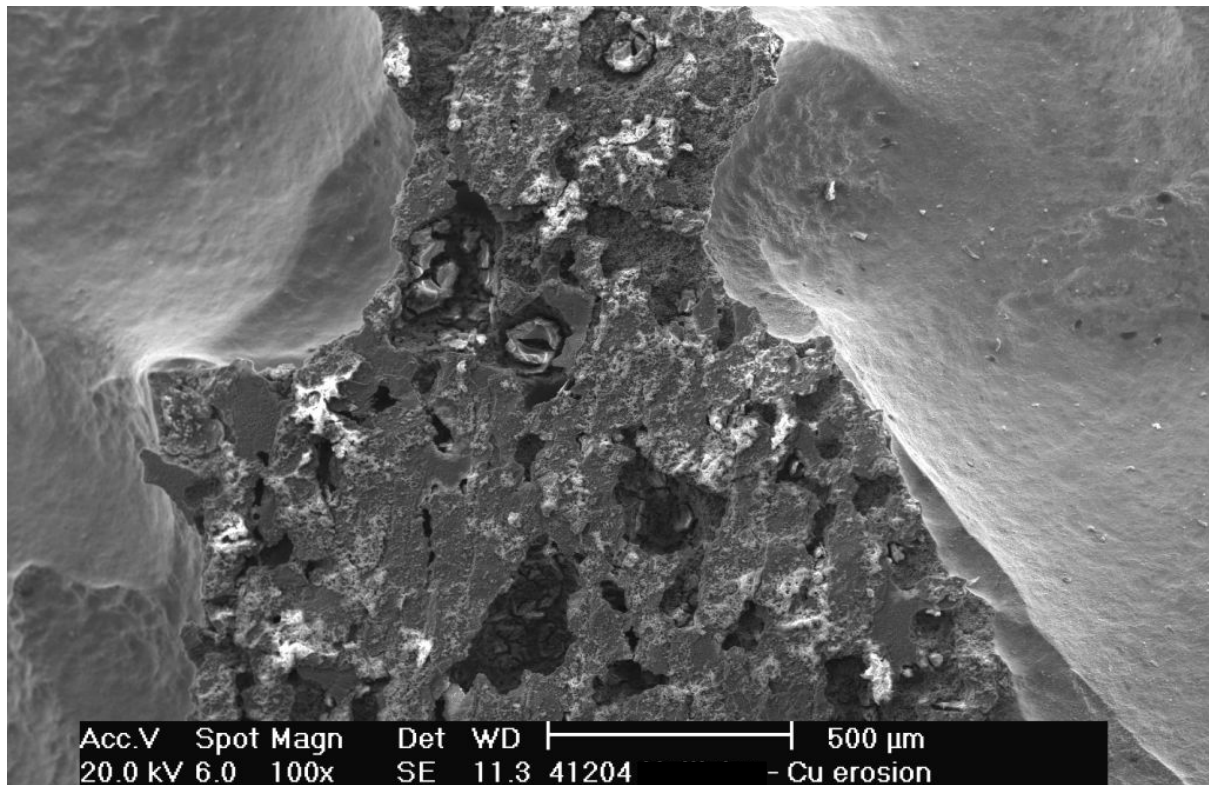
Figure 10: Brisbane residential tower — Island of oxide/carbonate/sulphate scale, with Erosion-Corrosion pits on either side. SEM secondary electron image.

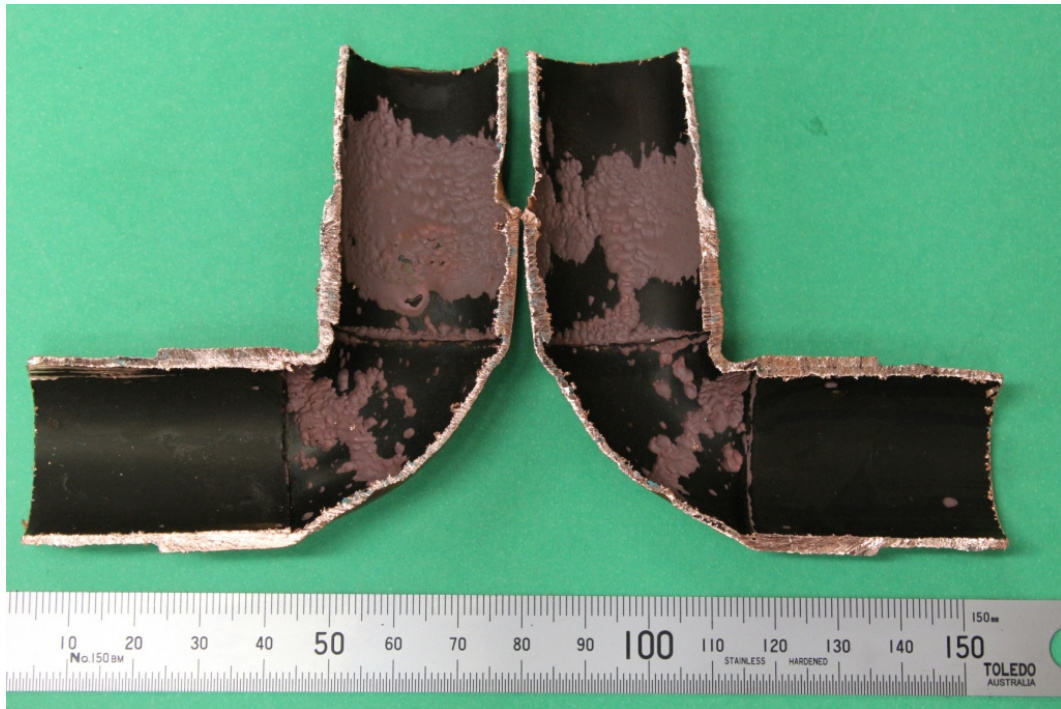
The sample (see Figure 11) showed the characteristic features of Erosion-Corrosion:

- Extensive regions of attack showing bare copper with no protective film;
- Islands of intact protective film, with undercutting;
- These regions being associated with a bend and joints which create turbulence.

Figure 11: Admiralty Apartments — Regions of Erosion-Corrosion associated with bend and joint.
