THE FORMS OF
CORROSION IN COPPER TUBE SYSTEMS
CONVEYING DOMESTIC WATERS

J. R. Myers¹
And
A. G. Kireta, Jr.²

CDA Copper Symposium 2001 – Plumbing Tube
Sheraton Crystal City Hotel
Arlington, Virginia 22202
25 April 2001

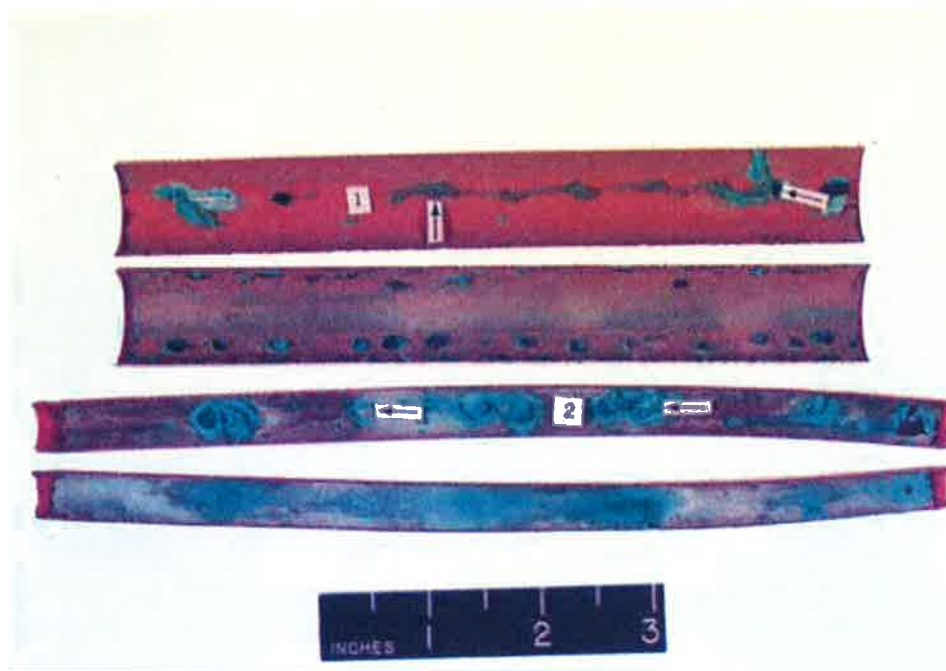
Flux-induced pits contain porous, reddish-brown cuprous oxide, with the pits being covered with relatively voluminous, friable tubercles of greenish-colored, copper corrosion products (Figure 1). Typically, the tubercles consist of basic copper carbonate (i.e., malachite) and/or copper chloride(s). The pits are not normally randomly occurring; they tend to occur preferentially along relatively narrow bands that are nearly parallel to the longitudinal axes of the tubes and fittings (i.e., along the "ghosts" of flux runs). Often, the bands/band of pits in these areas are covered with tubercle ridges (e.g., see top tube half-section in Figure 1) rather than distinct, hemispherically shaped, individual tubercles. Flux-induced pits also occur preferentially on the periphery of the sticky, petrolatum-base flux residues/runs, which often exist on the waterside surfaces when the plumbing technician applies excessive flux. When the latter is observed, it is not uncommon to also find globules of solder on the waterside surfaces of the tubes and fittings. Although flux-induced pitting can be expected to occur at or in the near vicinity of soldered connections associated with poor workmanship, cases are known where the pitting occurred over eight feet away from a fitting.

Figure 1 – The soldering flux-induced pits were covered with friable, greenish-colored tubercles of copper corrosion products. The perforations through the tube walls (i.e., see arrows) and most of the pits existed along relatively narrow bands, which were nearly parallel to the longitudinal axes of the tubes (i.e., along the “ghosts” of flux runs).

Soldering flux-induced pitting can be effectively mitigated by requiring plumbing technicians to use industry-standard materials and workmanship when installing copper tube systems. Fluxes used for soldering copper water tube systems should satisfy the requirements of American Society for Testing and Materials (ASTM) Standard Specification B813² and soldered connections must be made in accordance with the guidelines presented in ASTM Standard Practice B828³ and the CDA Copper Tube Handbook.

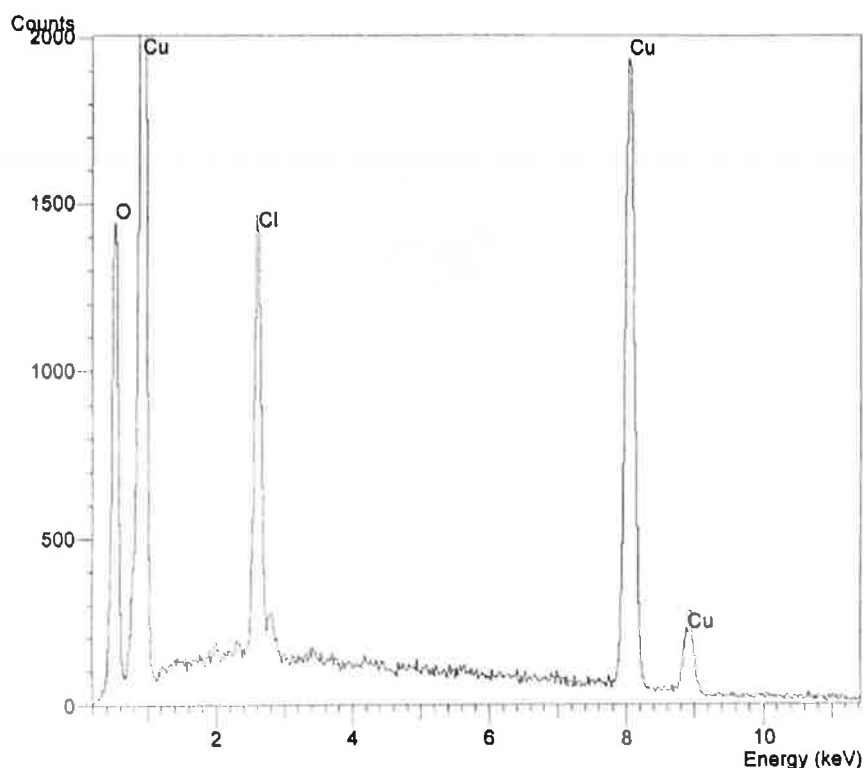
Soldering flux-induced pitting can be confirmed using energy dispersive spectroscopy. Chlorides in major amounts, and sometimes zinc, will be detected in the pits or on the edges of the pits (Figure 2). Copper chloride(s) coexists with the porous cuprous oxide at the pit sites. The latter is understandable because soldering fluxes commonly contain activating chlorides such as ammonium chloride, zinc chloride, tin chloride and/or hydrochloric acid.

Figure 2 - Energy dispersive spectroscopy normally reveals the presence of major amounts of chloride at the pit sites when the localized attack is soldering flux-induced.

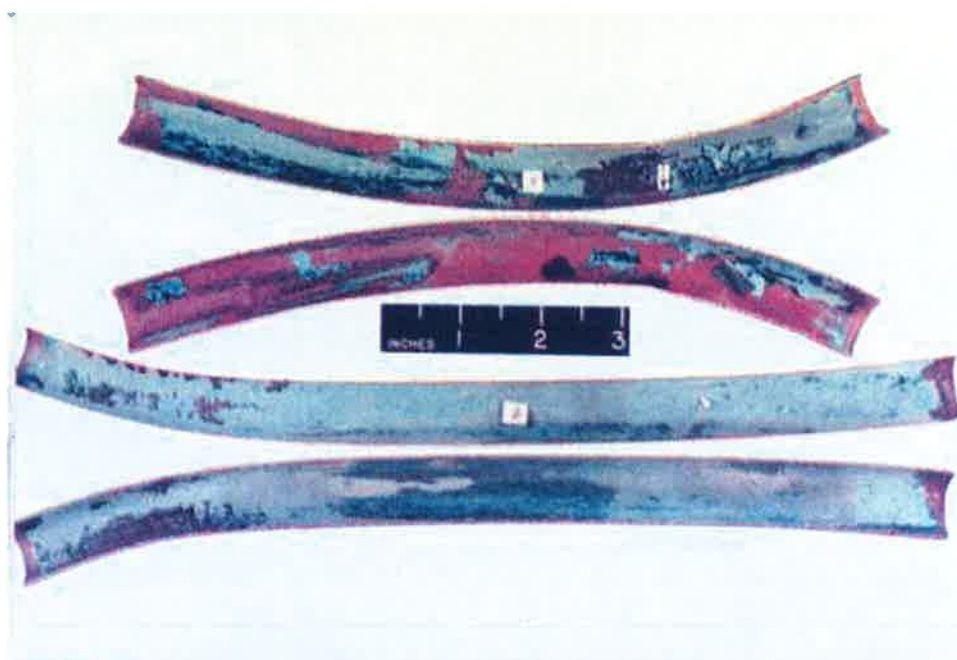
Hydrogen sulfide-induced pitting is randomly occurring on the waterside surfaces of the copper tubes and fittings (Figure 3). The corrosion-induced pits typically contain porous, dark, reddish-brown to nearly black cuprous oxide; the pits are normally overlaid with friable, greenish-colored tubercles of copper corrosion products. The tubercles most often consist primarily of copper sulfate that is sometimes admixed with some black, copper sulfide(s). Regardless of the tubercle composition, black, loosely adherent and porous layers of copper sulfide(s) are always associated with the pitting attack. The presence of these corrosion products can be readily verified using EDS and MCA.

Figure 3 - Hydrogen sulfide-induced pits are typically overlaid with friable, greenish-colored to blackish tubercles of copper corrosion products. Loosely adherent and porous layers of copper sulfide(s) are associated with the pitting attack (e.g., see upper two tube half-sections where these products had, in part, broken loose).

Hydrogen sulfide can be effectively removed from water supplies at the treatment plant by a number of techniques.^{4,5} For example, it has been successfully accomplished by reducing the pH of the well water followed by aeration in a forced-draft tower(s). Aeration removes the sulfide by the scrubbing action of the air and by oxidation. Lowering the pH of the water greatly reduces the size of the aerating equipment required.

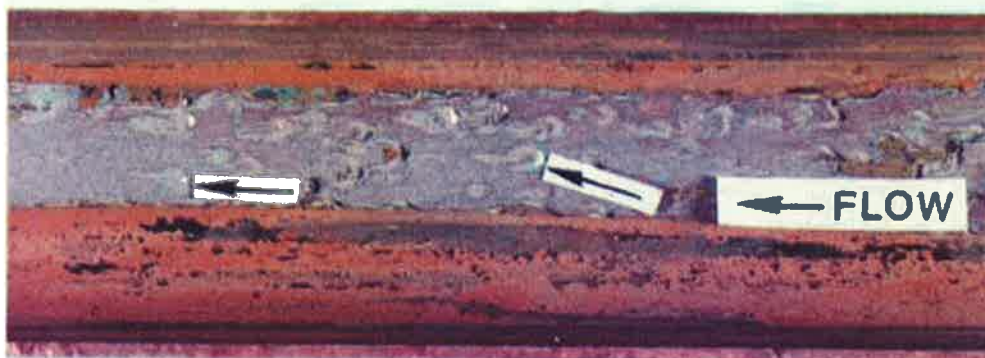
Erosion-corrosion can be readily recognized (Figure 4). The areas of attack are typically grooved and essentially free of residual corrosion products; the affected areas are normally bright and shiny like a new U.S. penny. This is understandable because the erosion phase of the rapidly repetitive, erosion-corrosion process removes the copper oxide(s) films from the copper surfaces. Often, the U-shaped pits in the areas of attack are sufficiently distinct that the direction of former water flow can be determined. When looking down on the surface, the orientation of the attack (i.e., the U-shaped pits) is such that it gives the impression of "horses walking upstream." Lengthwise sections taken through areas of erosion-corrosion will normally reveal undercutting which has the appearance of ocean waves wherein the wave crests face the direction of former water flow.⁷

Figure 4 - The U-shaped pits and associated perforations through the tube wall (i.e., see arrows) in the localized, corrosion product free area of erosion-corrosion were sufficiently distinct that the direction of former hot water flow could be determined.

Erosion-corrosion in cold-water systems can be effectively mitigated by insuring that the water pressure does not exceed about 80 psig and water velocities do not exceed the industry recommended 8 fps. Concurrently, plumbing technicians must use industry-standard workmanship when installing these systems.³

Erosion-corrosion in domestic hot-water systems can be effectively mitigated by insuring that, in addition to those requirements for the installation and operation of cold-water systems, the water velocity does not exceed about 4 to 5 fps,⁽²⁾ the water temperature is maintained at a safe and energy-efficient 120 to 130°F, and unacceptable amounts of abrasive suspended solids do not exist in the circulating water.⁸ With regards to the latter, the source of abrasive iron oxide(s) in the water is often the corrosion of steel, hot-water heaters/storage tanks upstream of the copper tube systems (i.e., a condition which can usually be corrected by properly selected and applied protective coatings, generally in conjunction with cathodic protection).

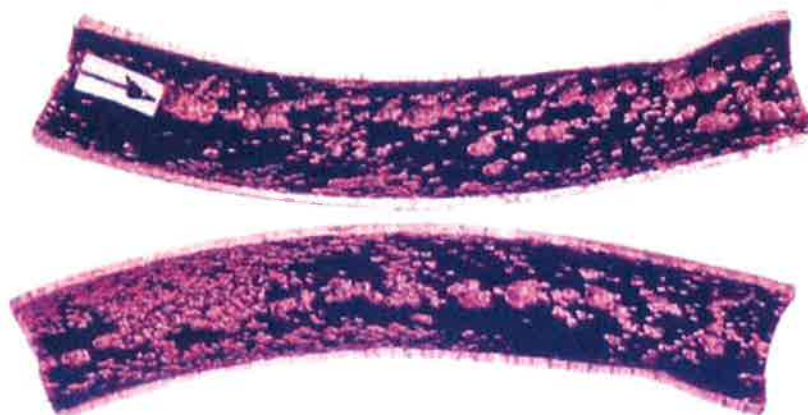
Cavitation, a special form of erosion-corrosion, can occur in domestic water systems if the system hydrodynamics are such that they allow vapor/gaseous bubbles to form at low pressure which are subsequently collapsed/imploded at high pressure. Bubble implosion, which produces very high localized pressures (shock waves) destroys the copper's protective tarnish film and creates boundary layer water temperatures which are much higher than that of the water being conveyed. Typically, cavitated copper can be recognized by the absence of residual corrosion products in the affected areas and the presence of bright copper and sponge-like rounded pits (Figure 5).

Figure 5 - The perforation through the tube wall (i.e., see arrow) existed in a localized area of severe cavitation. Surface heating by the cavitation process caused the formation of black cupric oxide on the copper where cavitation had not occurred in the cold water line.

Cavitation concerns in copper water tube systems can be most effectively mitigated by changing the system design so as to minimize hydrodynamic pressure differences associated with the flow of water.

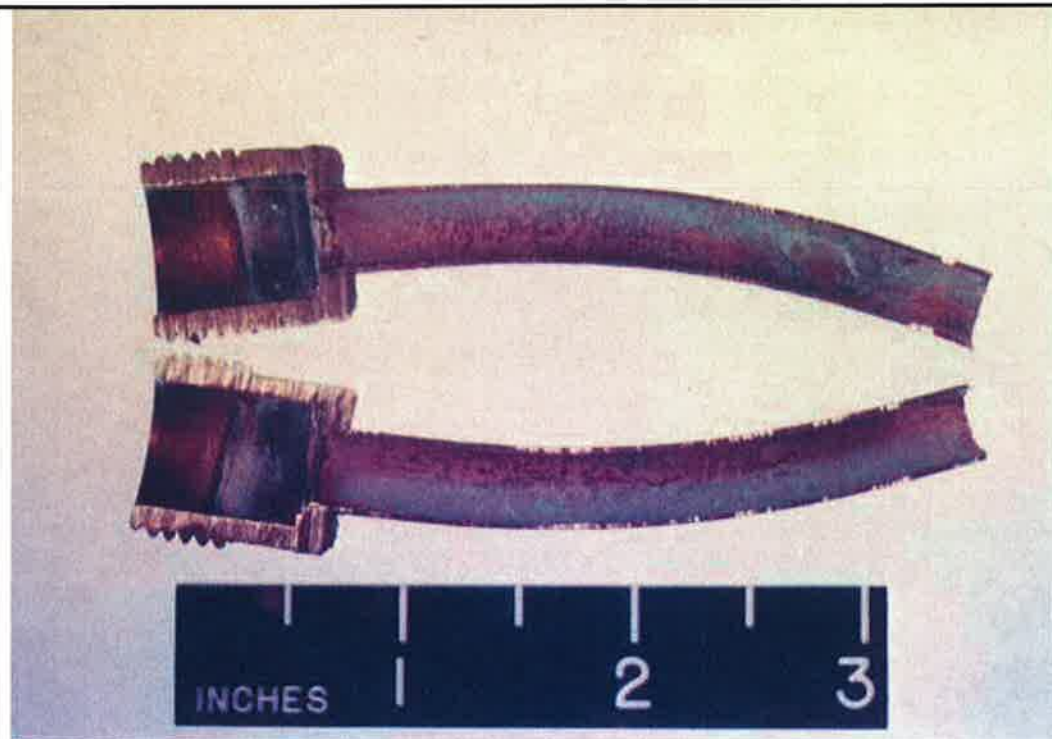
Cuprosolvency occurs because the waterside surfaces of the copper tubes and fittings do not form or completely form their naturally protective tarnish film of cuprous oxide. Rather, the copper surfaces develop a thin, loosely-adherent, flocculent-type, layer of bluish to bluish-green colored, copper corrosion products which typically include copper hydroxide (Figure 6).¹¹ Formed during periods of water stagnation, it is the removal of these products by water flow that creates the cuprosolvency concern.

Figure 6 - A loosely adherent, flocculent-type layer of bluish tinted copper corrosion products existed on the waterside surface of the tube. The cuprosolvency was clearly evident to be associated with failure of the copper water tube to completely passivate (e.g., see speckled appearance of the copper tube surface).

The vast majority of bluish/greenish-colored water concerns are self-correcting. Once a sufficient amount of water and its associated dissolved oxygen has flowed through the lines, the concern disappears because the copper, in time, forms its naturally protective tarnish film of cuprous oxide. In persistent situations, cuprosolvency can be corrected by raising the pH of the water to about 8 through additions of chemicals such as sodium hydroxide (NaOH) or calcium hydroxide, $\text{Ca}(\text{OH})_2$. Cuprosolvency can often be corrected at individual residences by the installation of neutralizing filters.

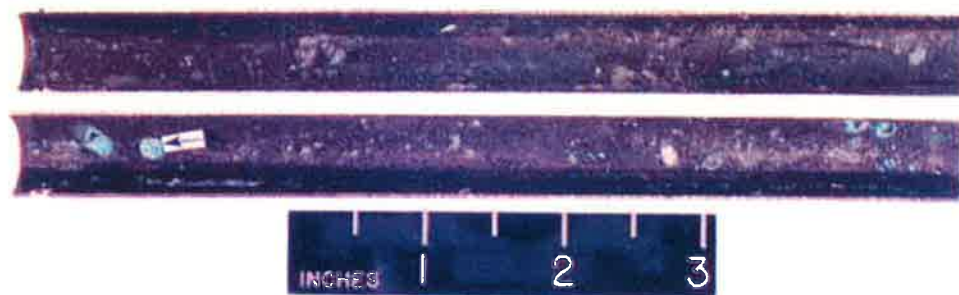
The source of the deposits on tubes and fittings is almost always suspended solids in the water conveyed. Often, they consist of iron oxide(s) and/or silica/sand (Figure 7). It is not at all unusual for the source of the iron oxide(s) to be the corrosion of cast-

Figure 7 - Concentration-cell corrosion in the form of pitting attack had occurred preferentially under the thicker layers of hydrated hematite (Fe_2O_3) and silica (SiO_2) deposits on the waterside surface of the cold water line. The perforation through the tube wall (i.e., see arrow) was covered with a friable tubercle of greenish-colored copper corrosion products.

Once the source of the corrosion-causing deposits is positively identified, suspended solids in water can normally be effectively eliminated. For example, the corrosion of cast-iron/ductile-iron mains and galvanized-steel service lines can be viably and cost-effectively mitigated by proper water treatment,¹² normally by the water purveyor. It is also well established that suspended solids in water can be removed by filtration,¹² either at the treatment plant or the affected building/residence and that improved dwell time at the treatment plant can help eliminate the post-precipitation of suspended solids in the water distribution system.

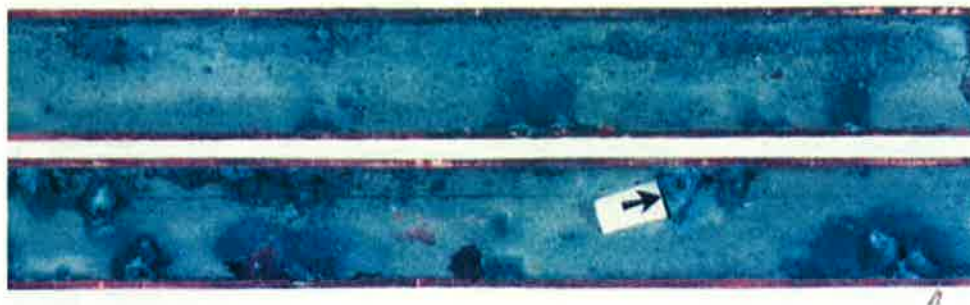
The randomly occurring corrosion-induced pits associated with the pitting attack contain porous, reddish-brown cuprous oxide, with the pits being overlaid with discrete, friable, relatively voluminous tubercles of greenish-colored copper corrosion products (Figure 8). Typically, EDS and MCA reveal that the tubercles consist primarily of basic copper carbonate.¹⁵ EDS will sometimes show that copper chloride(s) coexists with the porous, cuprous oxide in the pits. Where localized pitting has not occurred, there will be no significant deterioration by the water conveyed. Basically, the copper in these essentially unaffected areas will be covered with a protective tarnish film of cuprous oxide which, in general, will be overlaid with a thin layer of greenish-colored deposits from the water (i.e., typically malachite), the source of which is the pitting of copper upstream in the system.

Figure 8 - Randomly-occurring, tubercle-covered corrosion-induced pits (e.g., see arrow where a perforation through the tube wall existed) existed on the waterside surface of the tube which had conveyed a domestic cold water containing appreciable amounts of dissolved carbon dioxide in conjunction with dissolved oxygen.

The most viable and cost-effective solution to overcoming chemistry-related cold-water pitting in copper domestic water systems is to reduce the dissolved carbon dioxide content of the offending water to a sufficiently-low level.¹⁴⁻¹⁷ Raising a water's pH to about 8 while concurrently reducing its carbon dioxide content to less than about 5 mg/l will successfully mitigate the concern. Environmentally acceptable chemical additions for achieving this objective include caustic soda, lime, and soda ash. These are usually added to the offending water at the treatment plant. For a private residence, the same objective usually can be achieved by the installation of a neutralizing filter.

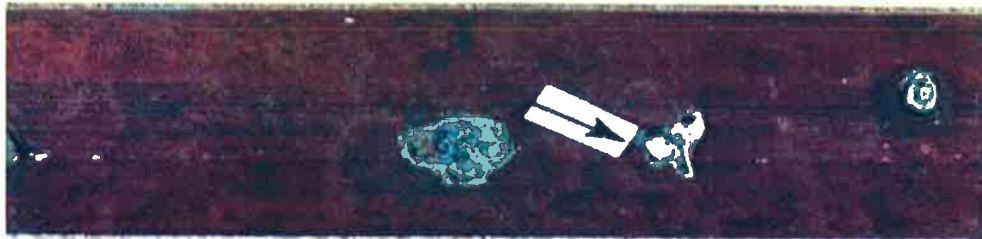
Typically, the corrosion-induced pits will contain porous, reddish-brown cuprous oxide and be covered with friable, relatively voluminous tubercles of greenish-colored copper corrosion products (Figure 9). EDS and MCA almost always reveal that the tubercles consist primarily of copper sulfate. Often, small amounts of the pit-initiating metal will be detected during EDS of the tubercles. It is unusual for EDS to detect any chloride-containing products in the pits.

Where pitting has not occurred and the copper is covered with a thin layer of cupric oxide, it is common to observe friable, loosely adherent layer of brownish-colored (Figure 10) or brownish-black colored deposits from the water (Figure 9). EDS of these products in the immediate vicinity of the pits will provide the insight required to identify the offending metal(s), which is primarily responsible for the pitting attack. The deposits will contain varying amounts of aluminum, iron, and/or manganese.

Figure 9 - The pits were covered with friable tubercles of greenish-colored copper corrosion products. Loosely-adherent layers of brownish-colored hydrated hematite deposits covered the black cupric oxide which existed on the waterside surface of the hot water line.

Hot water pitting by manganese and/or iron-containing waters can often be mitigated by reducing the concentration of these constituents in the waters to acceptable levels at the treatment plant. Iron and manganese-removal systems are available to accomplish this objective. For example, colloidal iron can be removed by coagulation, flocculation and precipitation or filtration. Sometimes the iron content of a water can be sufficiently reduced by, for example, mitigating the corrosion of hot-water heaters/storage tanks, cast-iron/ductile-iron mains, and/or galvanized-steel service lines upstream of the copper tube system. Cases are also known where the hot water pitting was effectively mitigated by reducing the temperature of the water to a safe and energy efficient 120 to 130°F. Properly blended sodium silicate – organic polyphosphate inhibitors added to the water have also been known to mitigate the corrosion concern.

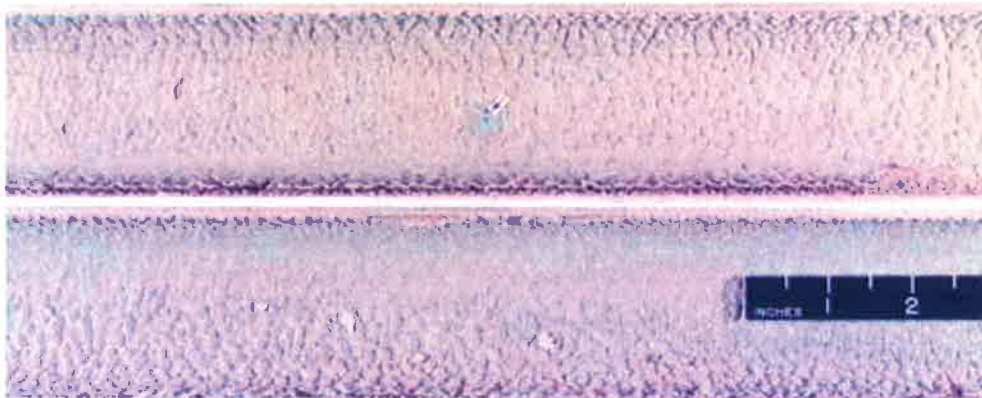
Figure 10 - The perforation through the tube wall (i.e., see arrow) was covered with a friable tubercle of greenish-colored copper corrosion products. In general, the cupric oxide on the copper tube surface was covered with a relatively-thick, loosely-adherent layer of brownish-colored deposits from the hot water conveyed. EDS revealed that the brownish-colored products contained significant amounts of aluminum.

The hot-water pitting associated with the presence of aluminum in the water has been effectively mitigated by raising the pH of the water to about 8.5 while reducing the aluminum content to less than about 0.1 mg/l. Often, the aluminum content of a water, as well as its sulfate content, can be reduced to an acceptable level by simply reducing the amount of aluminum sulfate used for coagulation at the treatment plant and/or insuring adequate coagulation, settling, and filtering of the water before it is distributed. Reducing the temperature of the hot water from 165°F to 130°F has also been known to correct the pitting concern. Recent studies also suggest that the aluminum contents of domestic hot waters can be reduced to acceptable levels by avoiding the use of sacrificial aluminum-alloy anodes in the hot water heaters.
