THE EFFECTS OF TEMPERATURE AND VELOCITY ON THE DEGRADATION OF COPPER PIPES IN RECIRCULATING HOT WATER SYSTEMS

Report Prepared for The Institute of Plumbing
Australia

April, 2015

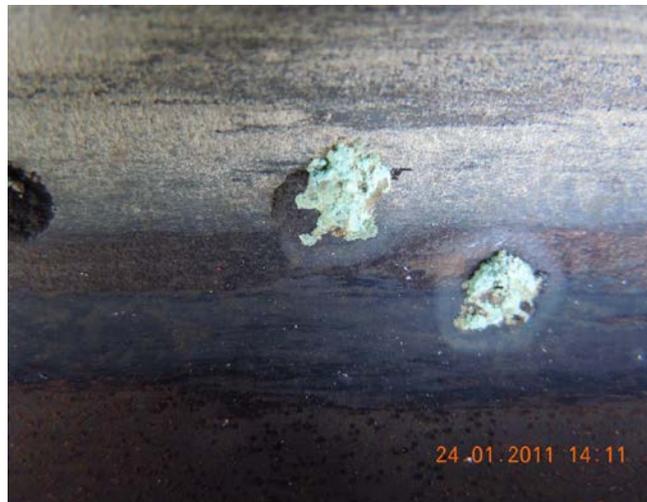
Figure 1: Typical Type 2 pitting corrosion product appearance on pipe experiencing hot water pitting corrosion. (Author’s collection)

The photos of Type 2 pitting shown above in Figures 1 and 2 were taken from a RHWS in the Hunter region of NSW, where waters of pH below 7.4 and temperatures considerably in excess of 60°C were experienced leading to multiple pipe failure. In Sweden (Mattsson and Fredericksson, 1968) ratios of bicarbonate to sulphate of less than unity were blamed for this phenomena, but this has not been observed in Australia where temperature appears the main culprit. RHWS in Australia are known to be run at very high temperatures to avoid issues with Legionnaire's disease, but this can lead to issues both with the Type 2 pitting described here and corrosion/erosion of copper which is the main focus of this paper.

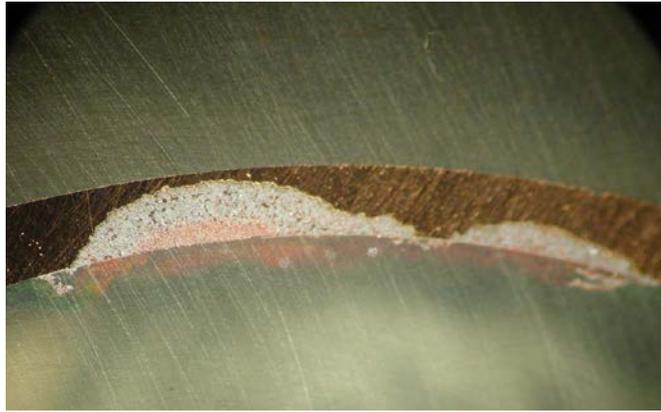
Figure 2: Cross-section of pit from under mound shown above in figure 2.

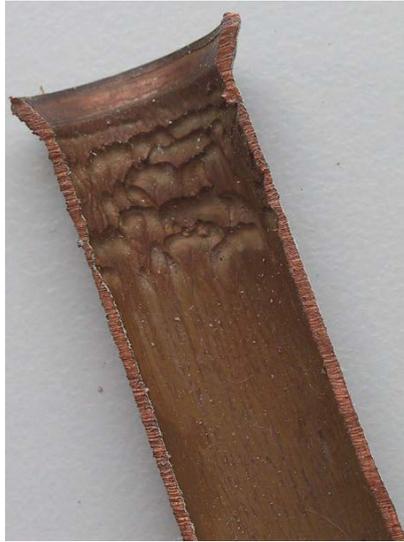
Figure 5: Deeply 'scalloped' pipe surface, typically near pipe joint. (Nicholas, courtesy of G. Moore, 2014)

Typically, the appearance of copper pipe surfaces exposed to corrosion/erosion can be unambiguously identified, with horseshoe shaped pits with their open ends facing downstream (Gates, 2012, Nicholas, 2014, Metals Handbook, 1987). Typical photographs of corrosion/erosion are shown below in Figures 3 – 5;
