Project No.: 41204

Subject: Leaks in Copper Pipe at Shafston Mansions

Date: 30 October, 2008

Leaks in Copper Pipe at Shafston Mansions

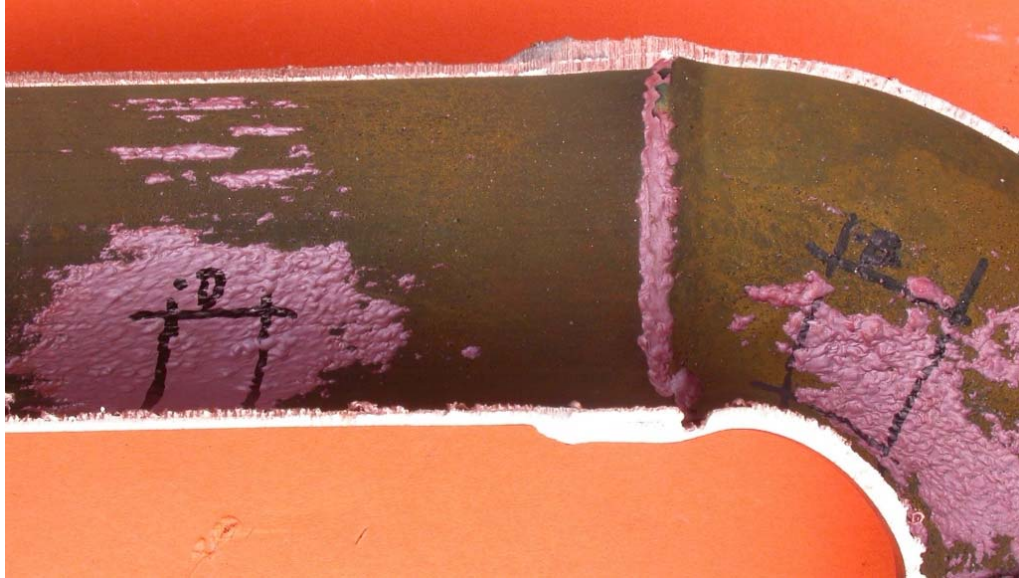
Figure 12(a): Location of samples for SEM examination: (right) sample “B” (Bend) and (left) sample “D” (Downstream of bend).

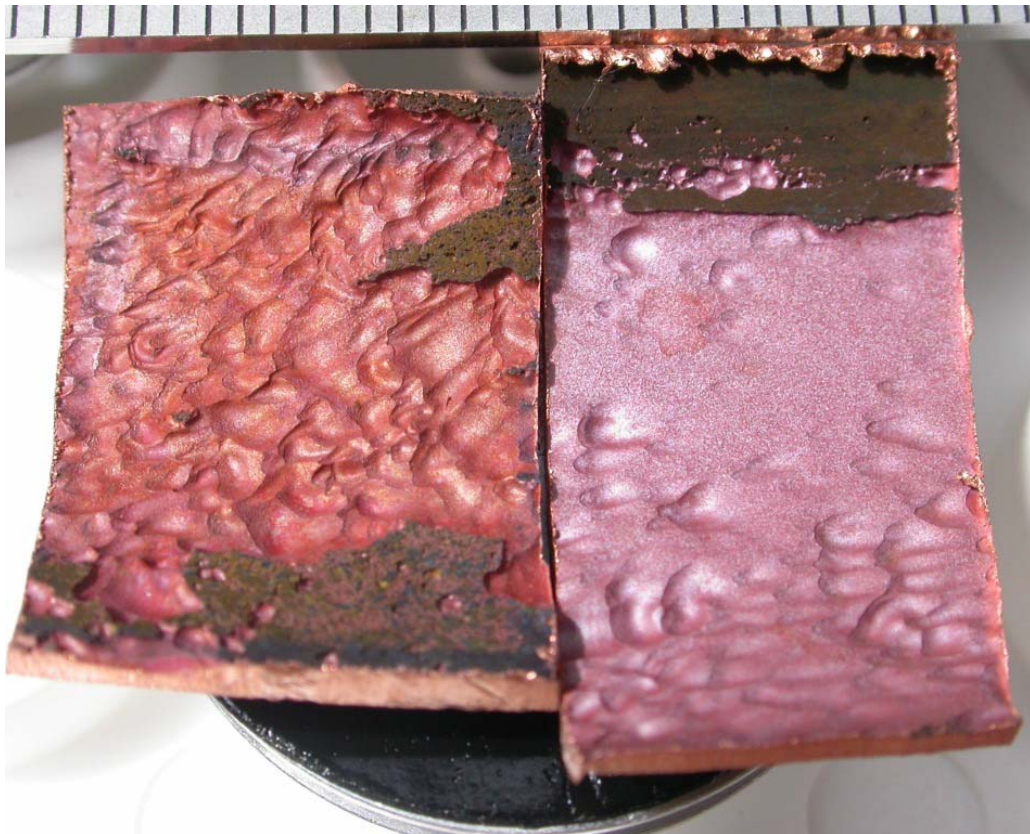
Figure 12(b): SEM samples mounted on SEM stub: (left) sample “B” (Bend) and (right) sample “D” (Downstream of bend).

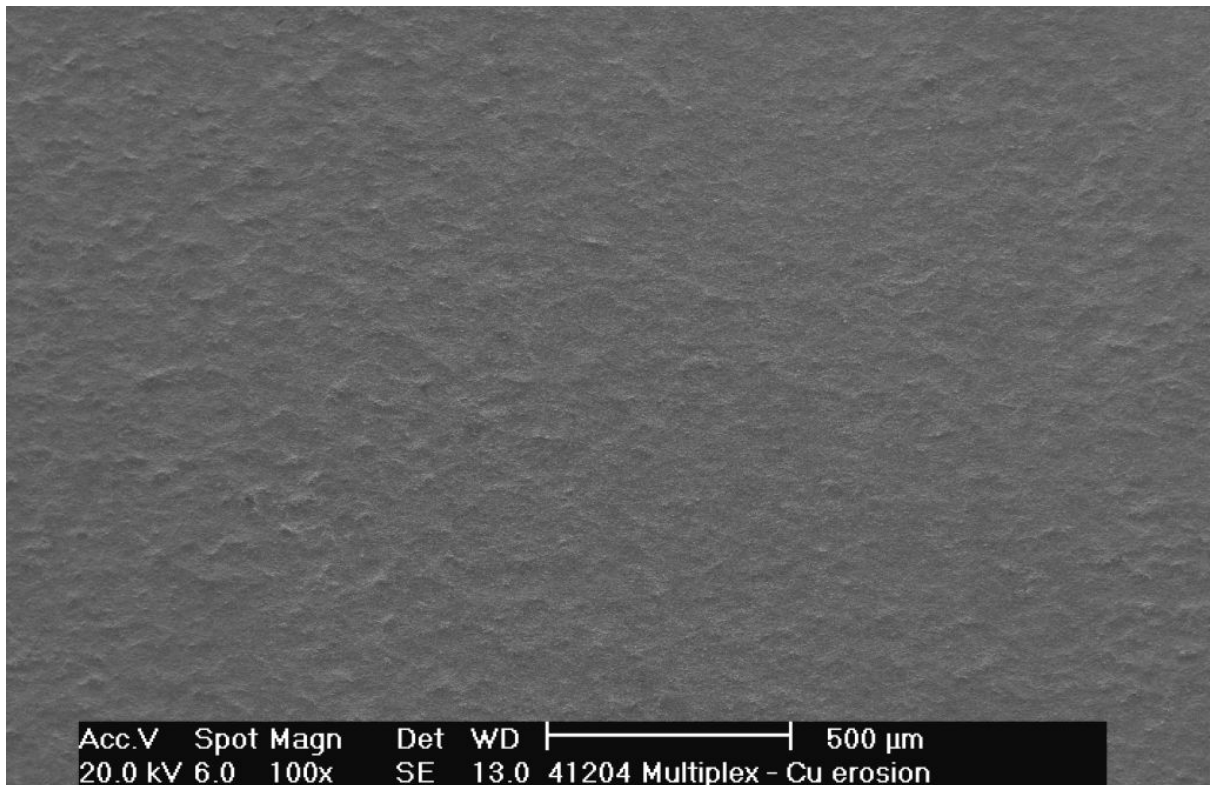
Figure 15(a) to (d) is a series of SEM secondary electron images (SEI) at 4-fold increments of magnification from 100× to 6400×, showing the bare-metal surface from sample D. The metal surface appears substantially flat and fairly smooth even at moderately high magnifications. At high magnification (6400×), the scale of surface roughness can be seen to be uniform, with features in the range of about 0.5–2 µm across. There are no obvious signs of either grooves or embedded mineral particles, such as might suggest Solid Particle Erosion at low impingement angles (Abrasive Erosion). The uniform and relatively fine-scale surface roughness could be consistent with active corrosion alone.

Figure 15(a): Sample “D” (Downstream of bend). Low-magnification (100×) secondary electron image of a flat smooth region of the eroded surface.

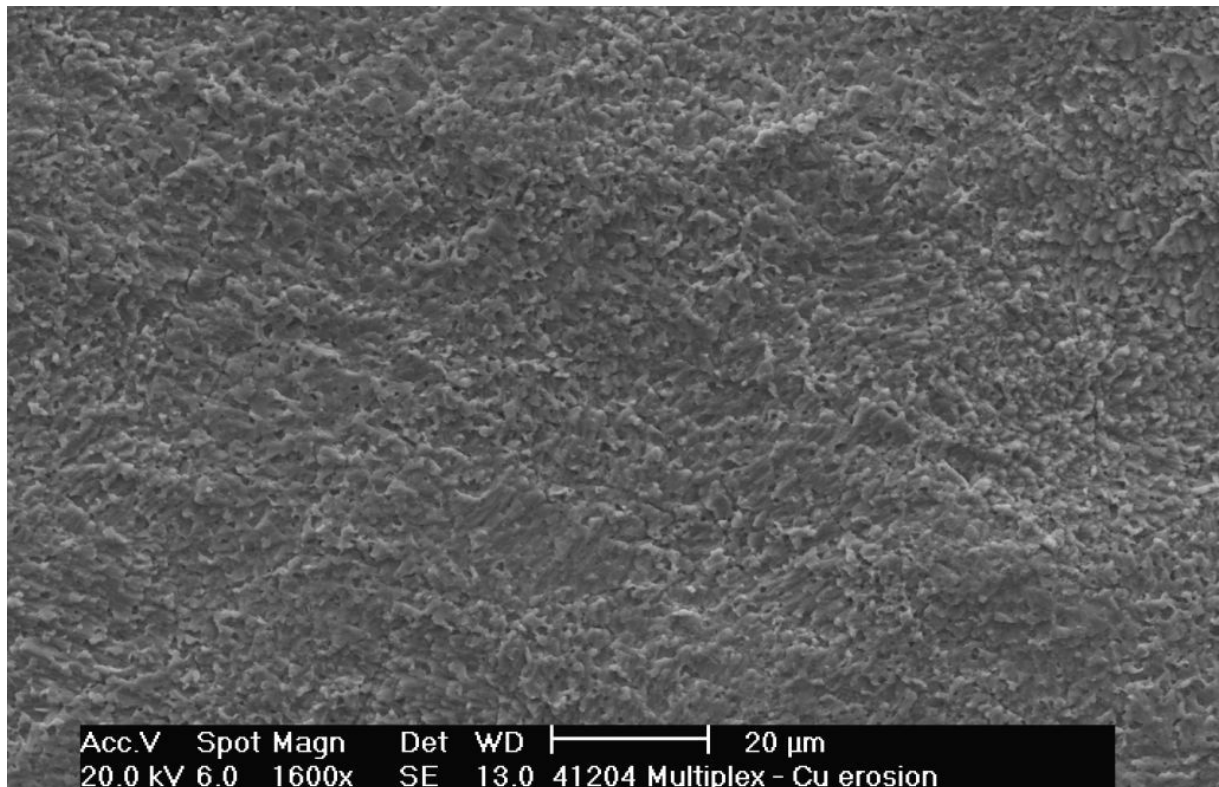
Figure 15(c): Sample “D” (Downstream of bend). As per Figure 15(a) and (b) but at medium-high magnification (1600×).

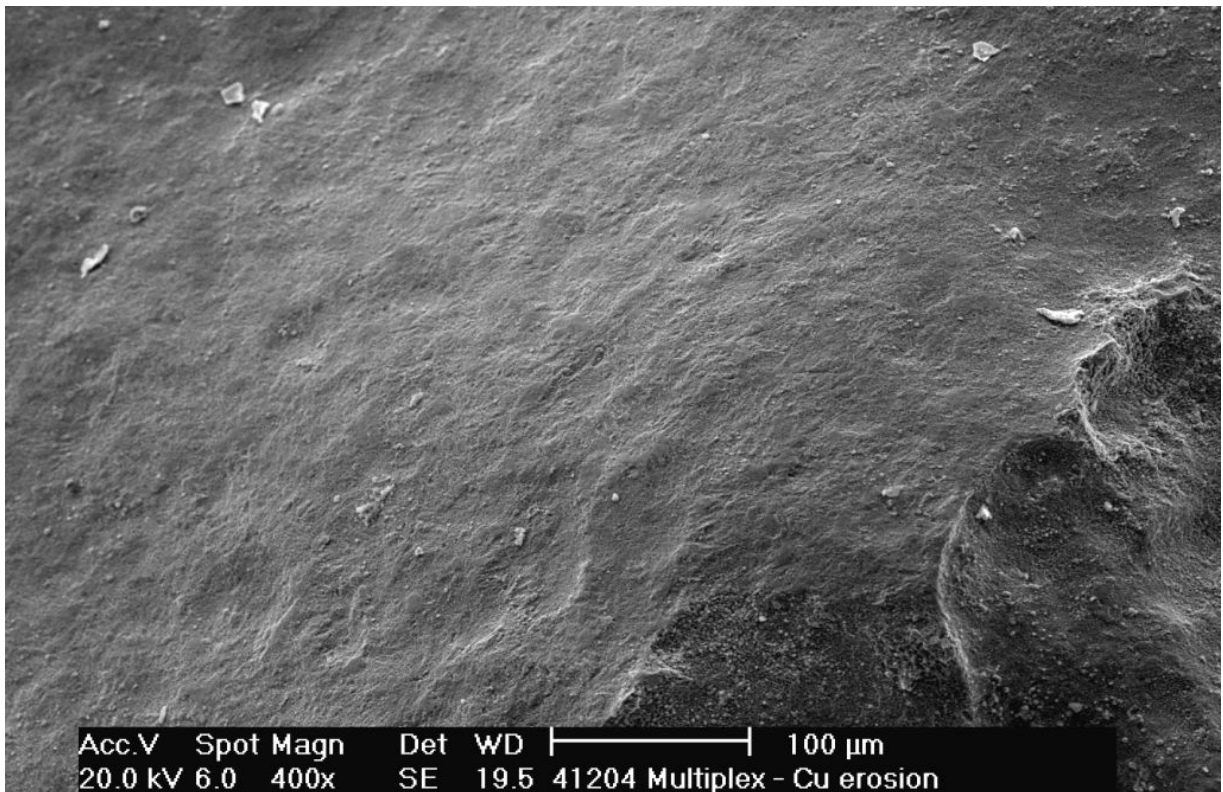
Figure 16(a) to (d) is again a series from 100× to 6400×, this time showing sample B. The low magnification image (a) shows the rough scalloped surface resulting from turbulent flow in the bend. Figure 16(b) to (d) show one of the “hill” regions within (a). The surface features are broadly similar to those seen in sample D, except that there are several small patches of smoother material. It is difficult to know what has caused these smoother patches, but they are not suggestive of Solid Particle Erosion.

Figure 16(b): As per Figure 16(a) but at medium magnification (400×).

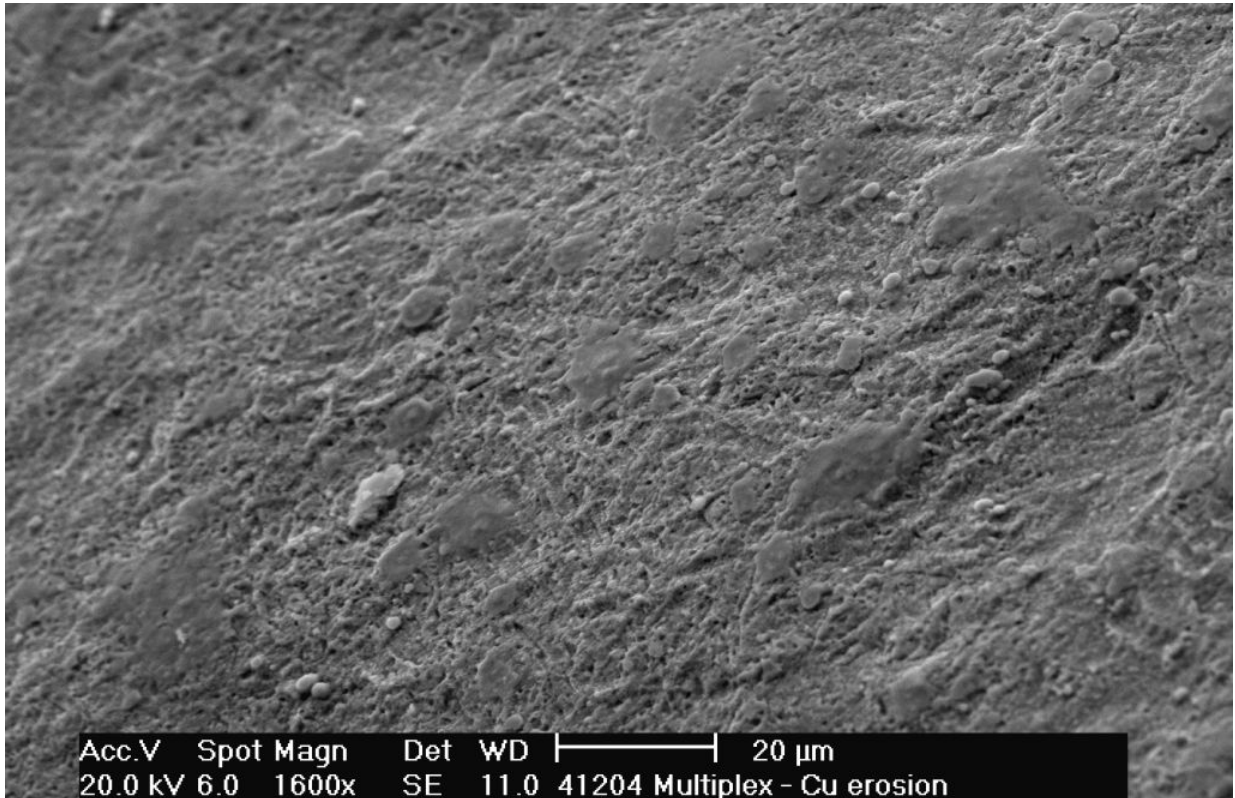
Figure 16(c): Sample “B” (within Bend). As per Figure 16(a) and (b) but at medium-high magnification (1600×)
