Project No. 41994

Subject: **Erosion-Corrosion of Copper Pipes in Hot Water
Reticulation Systems —
Case Studies and Wider Implications**

Date: 7 July 2014

Prepared By: **J.D. Gates**, BSc(Hons), PhD, CPEng, NPER, RPEQ, CMatP

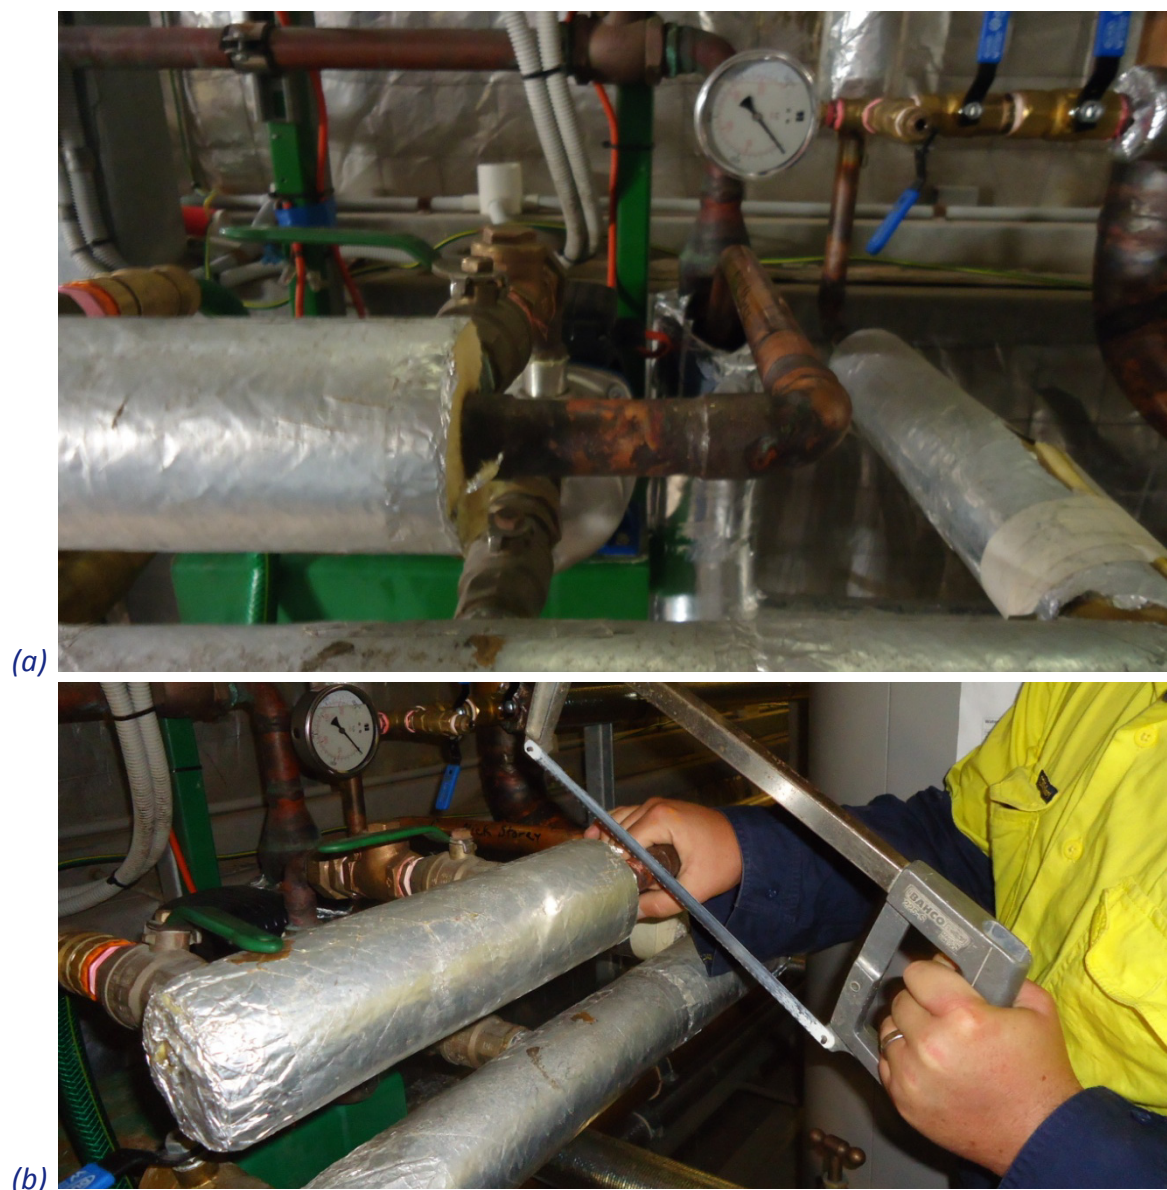
Figure 1: Cropped reproductions of photographs provided by Aquatherm showing pipe samples being cut from Jacksons Landing, Quarry Building.

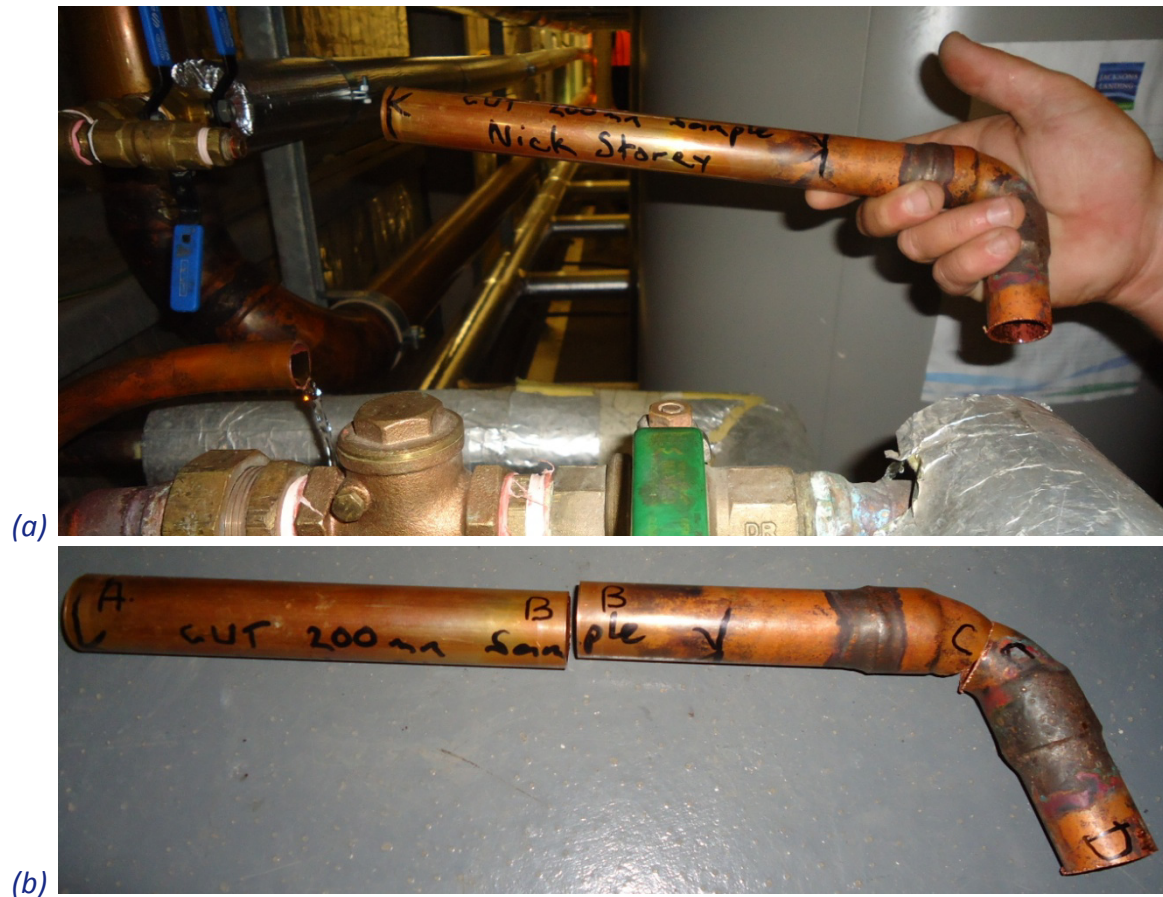
Figure 2: Cropped reproductions of photographs provided by Aquatherm showing pipe samples after cutting from Jacksons Landing, Quarry Building.
